FULVIA

2nd SERIES

COUPE
SPORT

**OWNERS NOTES:
2. RESTORATION (Part 1)**

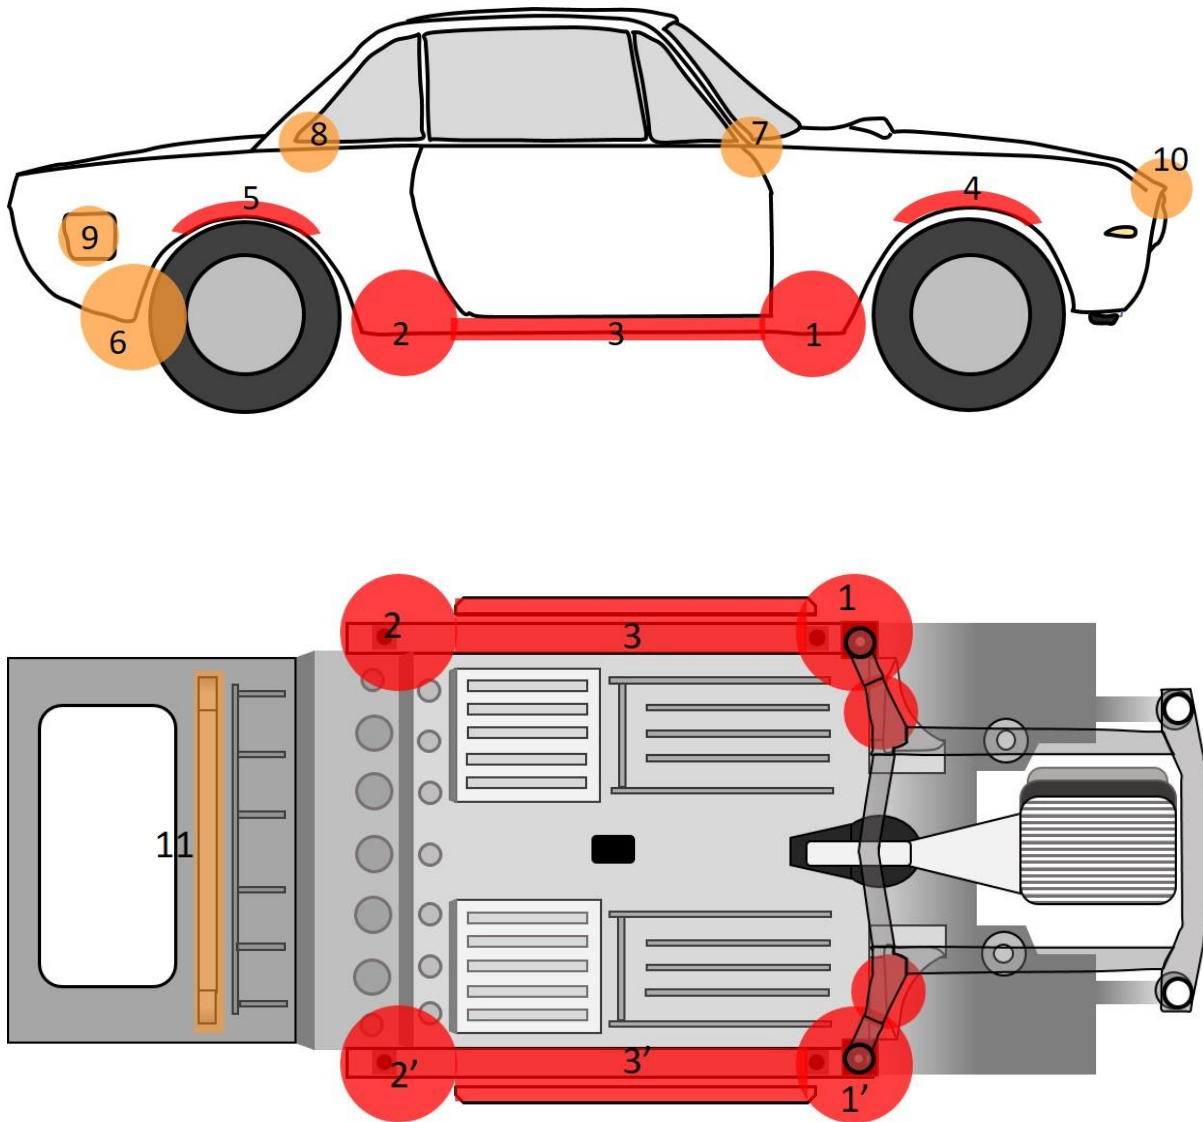
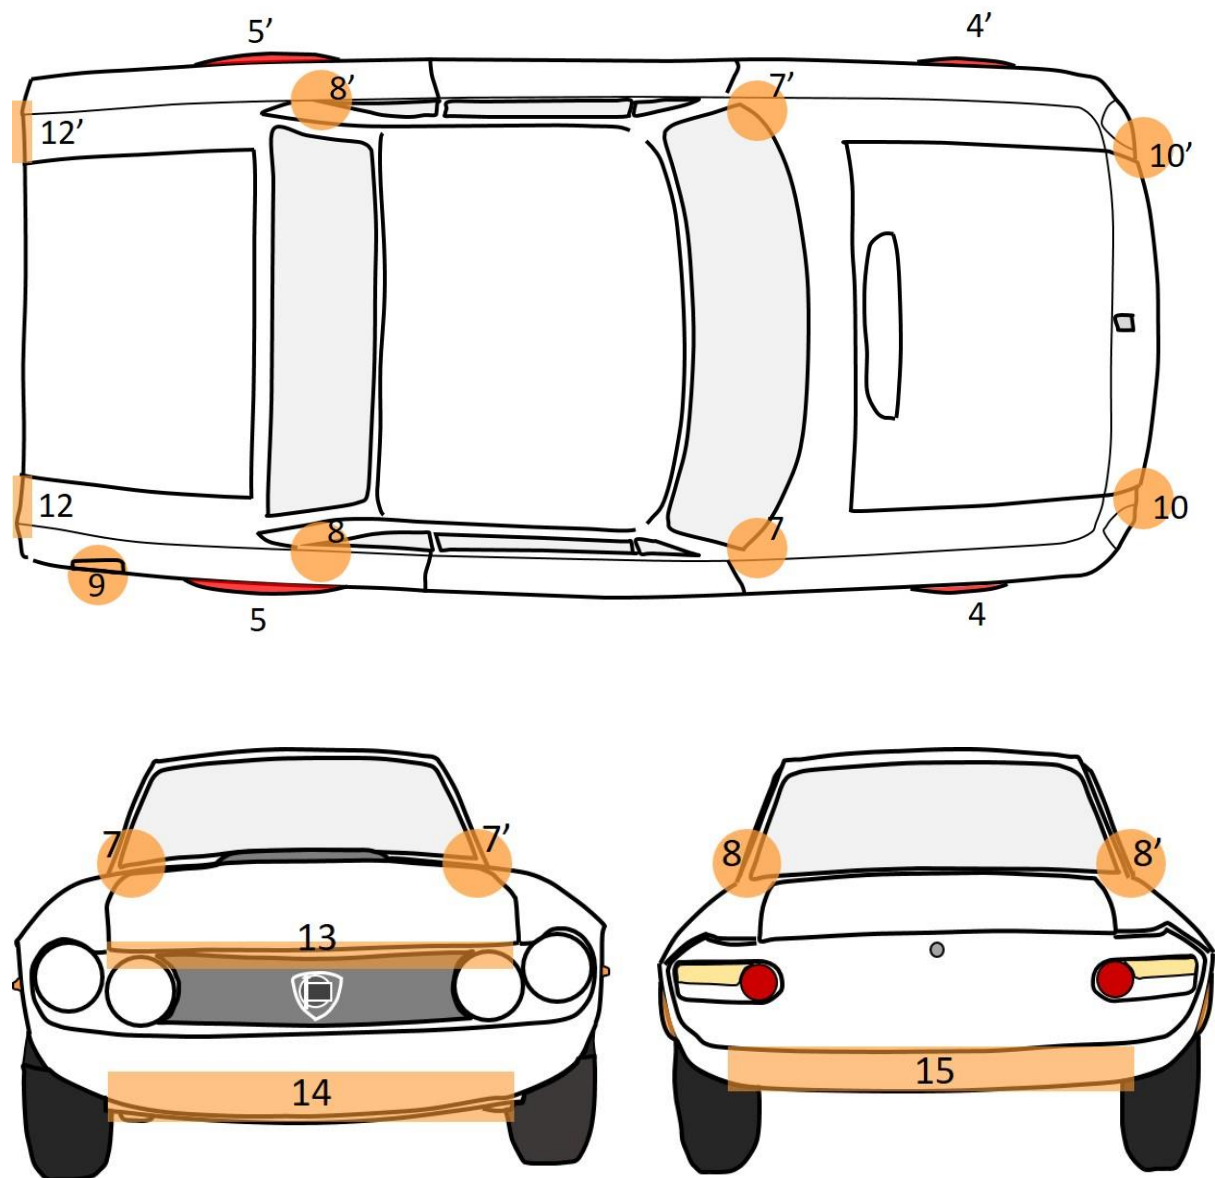
The Fulvia Coupe bodywork areas that are prone to corrosion and therefore likely to need attention are shown on the diagrams below. They have been divided into two groups:

Critical Areas (red) – these are responsible for the safety and integrity of the structure. Full inspection will require removal of some sound areas of external bodywork. Visible failure in one area [subframe mounting point, the floor beneath the sill, or the transverse box-section at the junction of the foot-well with the front wheel arch] may warrant inspection of other areas [the rear of the sill, rear wheel arch and lower B-post], since their causes of corrosion may be connected [ingress of water into the sill which is distributed along the length of the inner and outer sills]. Removal and repair should be carried out with the car properly supported and braced to avoid distortion. Improvements to the original design can be made by adding a central plate between the inner and outer sills, as well as drilling 10-13mm drain holes/cavity-wax injection points in the sill and other box-sections

Non-critical areas (orange) – these are localised in extent and are not critical for structural integrity (although they may lead to MOT failure). They are often areas where mud and water can be trapped, causing corrosion. Repair can often be effected without extensive work and improvements can be made by adding drain holes, applying paint and cavity wax and carrying out regular cleaning.

1 – Sill, subframe leg & mounting point, footwell box-section and internal support for A-post

2 – Sill and Internal support for B-Post

15 – Rear Valance (bottom edges and junction with the rear panel)

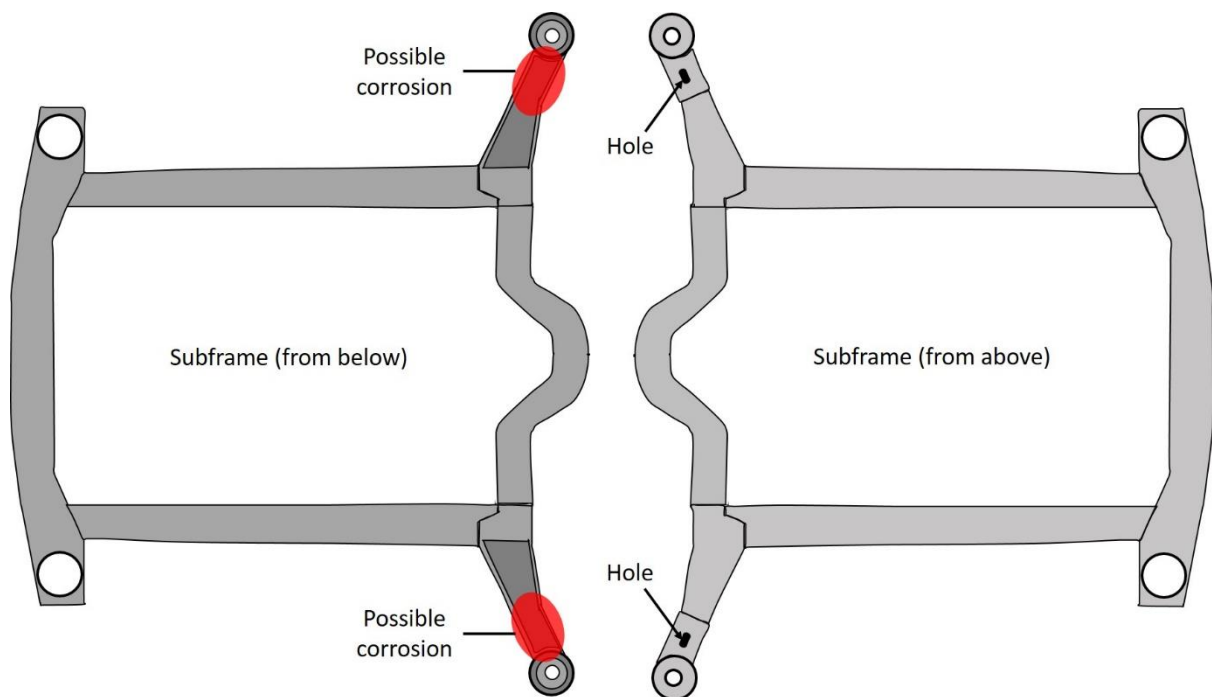
The subframe is well-constructed from thick steel (approx. 14SWG/2mm) – however, it comes with an Achilles heel. Lancia designed the rear subframe out-riggers with a hole in the top surface which, in normal use, allows water and dirt to enter the box-section. No blanking grommet was provided for this hole and no drain hole is present in the lower surface to allow water to escape. This leads to internal corrosion of the box, which is only detected on the outside when the outrigger is close to failure. At this point, perforations may be visible in the lower surface of the box and the inner surface of the mounting point (area highlighted in red, above).

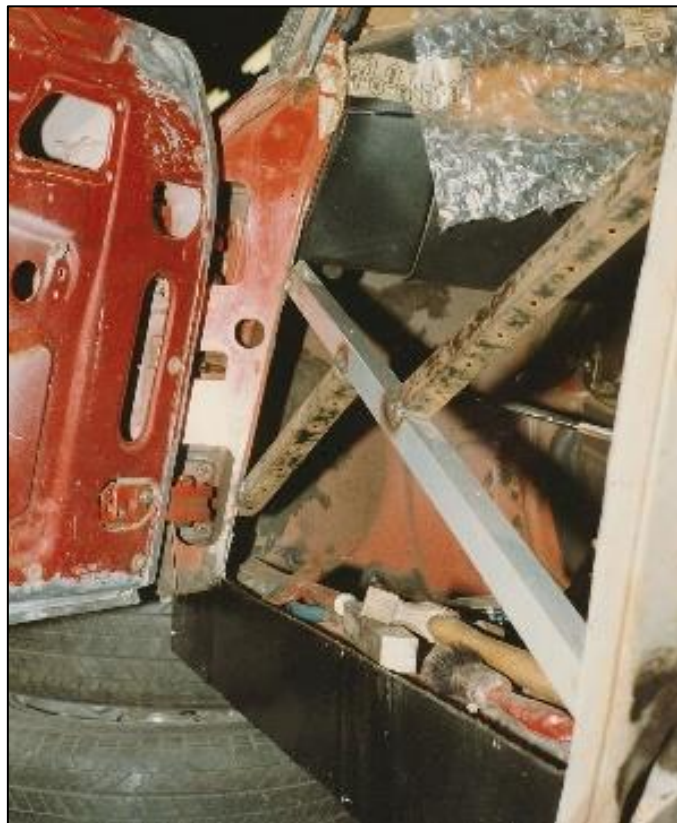
Removing the outer sill and a portion of the front wing will expose the area around the rear subframe mounting box. If this is badly corroded, it is likely that some distortion of the body has occurred. This was the case in the restoration of the 1971 1600HF Coupe, where the right-hand door overlapped the body by 5mm in the lower rear corner.

The bracing was left in place until repairs to the subframe mounting point had been completed, at which point the subframe was reinstalled. With the body supported across the middle as well as at either end, the bracing was removed and the door refitted. Having established that the fit was good, the whole side was stabilised by completing the inner sill and adding a central membrane along the length of the car (see photo below and section 2.5).

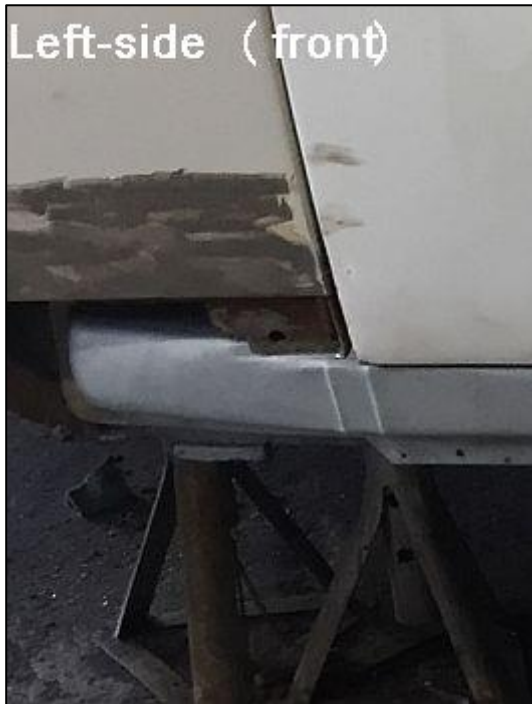
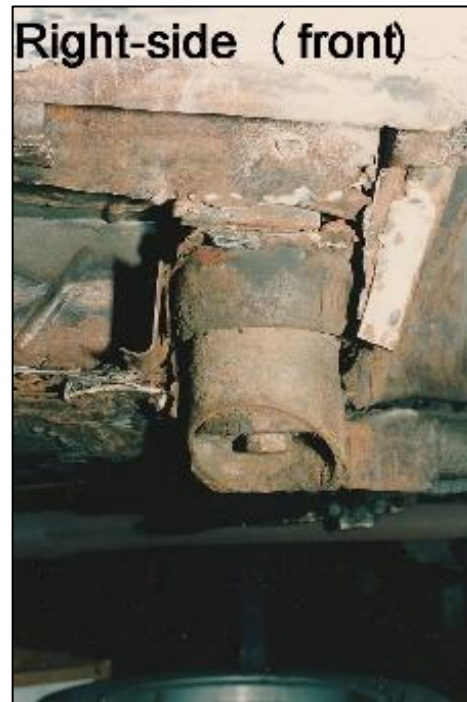
In the case of the 1600HF (above right), the outer sill extension and the area of the panel around the subframe mounting box, as well as the box itself, were badly corroded or missing. A previous repair in this area had consisted of connecting the floor to one of the remaining faces of the box using a strip of bent metal, leaving little support for the A-post.

The first step in the restoration of this area is to remove a section of the lower wing, between the door edge and the wheel arch. This will expose the lower portion of the A-post panel and the outer sill extension that supports the A-post (below left, after replacement of sill).

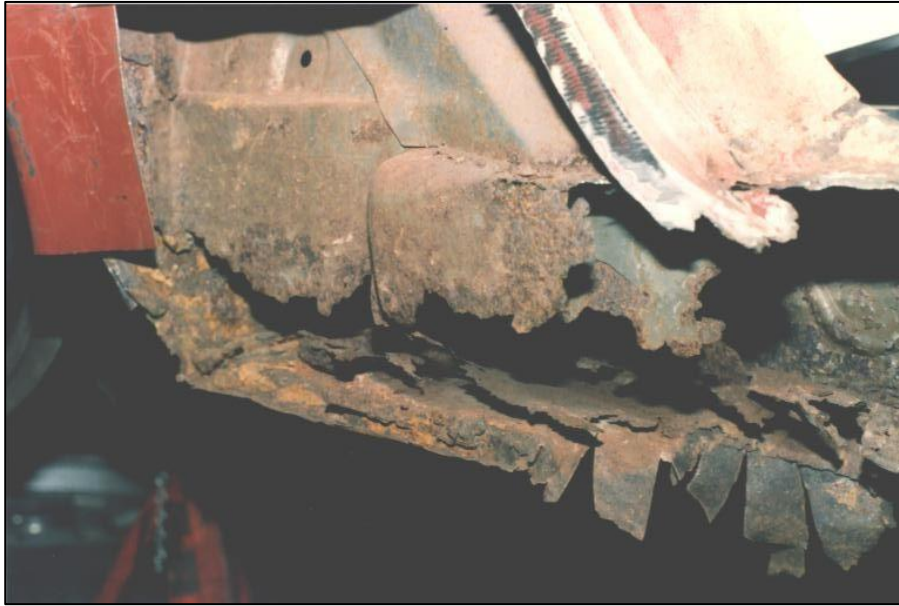
After removal of a section of the 1600HF rear wing, at the front of the rear wheel arch, severe corrosion was also found in this area of the sill. This wheel arch showed signs of earlier repairs and the extension at the end of the outer sill that forms the B-post support was no longer connected to the rest of the outer sill. The lower section of the B-post panel was also corroded, with no connection to the floor.

While disappointing, this was a lesson that a car with serious structural issues can drive deceptively well. Visible corrosion in the critical areas shown in section 2.1 should be investigated and addressed, particularly when combined with small bodywork distortions or cracks. The decision was taken to remove any corroded metal and reconstruct the sill and its components, while also trying to prevent future corrosion and extend the time between repairs.

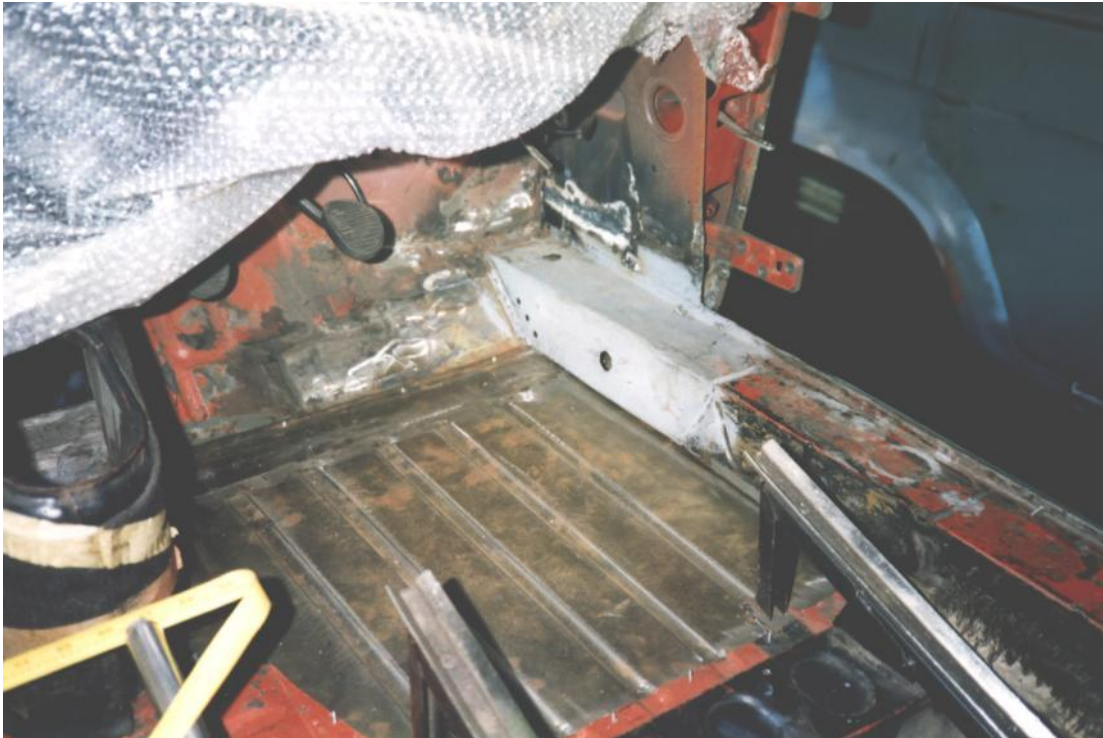
If the front section of the inner sill needs to be replaced (see Section 2.5), it is likely that the floor will also be corroded. Although small areas can be plated over, a better long-term option is to remove the corroded metal and replace it. While small sections of floor may be fabricated, it proved difficult to replicate the pressings which give the floor its strength and produce a satisfactory join between the old floor and any new section without distortion and introducing flexing.

A better option is to replace a large section of the floor (approximately wheel arch-to-seat runner and sill-to-gearbox tunnel) using one of the commercially available repair sections.

If the repair panel and the existing floor are overlapped and spot welded, the repair panel should be laid below the floor, so that the external joint faces towards the rear of the car. This allows water running under the front of the car to flow over, rather than into, the joint (see above). All joints should be protected with seam-sealer before painting.

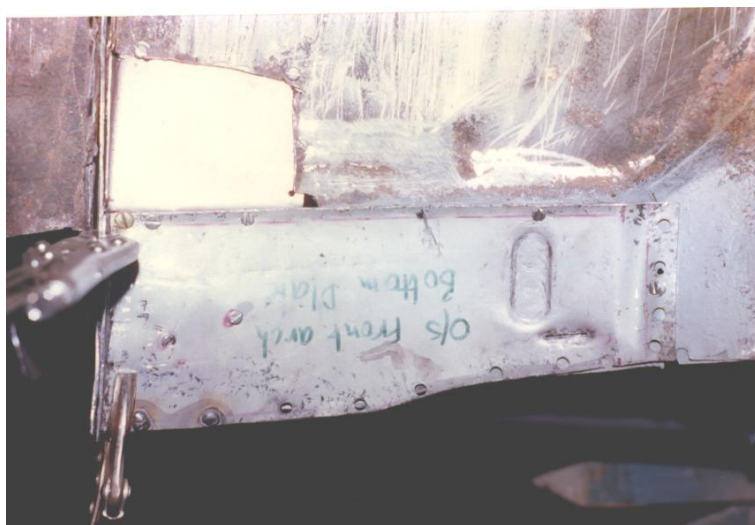
Since the box has been formed between the outside of the car and the bulkhead, water can enter the box either through gaps in the welds along the edges of the external cover plate or via the inner sill and its junction with the bulkhead. Corrosion of the inner sill, subframe mounting box and triangular box are therefore linked and all should be checked in the event of failure of one of them.

It is advisable to add a drain hole/cavity-waxing point at the lowest part of this box, near the subframe mounting box (see inset). This can be used to protect the inside of the box and then sealed with a grommet in normal use. Templates for making replacement sections of this box are given in Appendix 5. If replacing this box, the use of thicker steel than standard is recommended for use as the outer plate (1.2-1.4mm, 17-18 SWG).

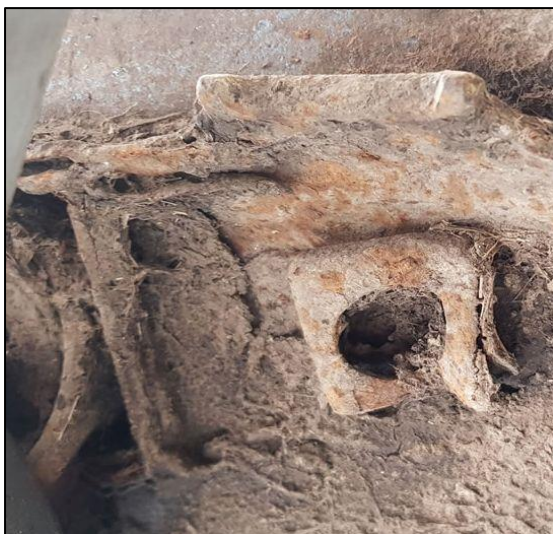
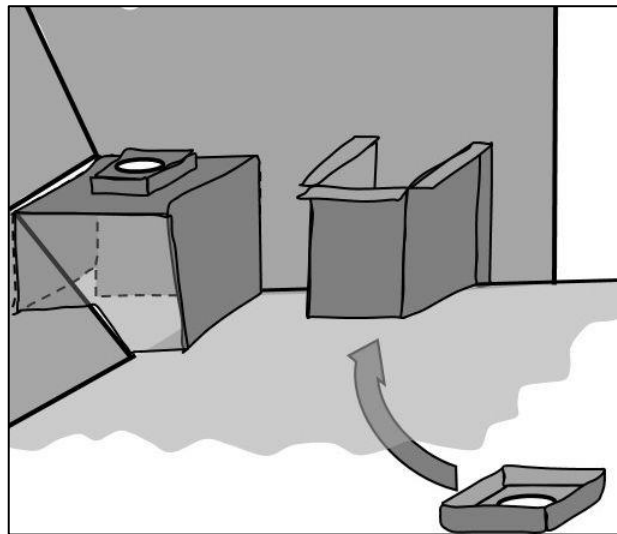
One set of jacking points consist of 45mm reinforced square plates which are welded to the underside of the floor using two tabs. Two are placed behind the subframe mounting boxes (see below, left) and the other two sit in front of the rear wheel arch. Unfortunately, in use, water and dirt collect in the gap between the plate and the floor, leading to the corrosion of both.

Replacement items can be purchased online. However, with the inner sill removed to replace the subframe mounting box, it is relatively straightforward to replace the jacking plate with a reinforcing box that distributes weight over the vertical A-post panel, rather than concentrates it on a small section of floor.

The proposed modification is shown above in the figure on the right. Fitting requires removal of a 45mm square section of floor. The floor edges should be welded to the side of the box and waterproofed with seam sealer. All dimensions and cutting plans are given in Appendix 6. The same cutting plan can also be used to make a standard replacement plate, if preferred. The modified

arrangement has been used on the 1971 1600HF for over 25 years, with no signs of corrosion to the jacking point or to the surrounding floor.

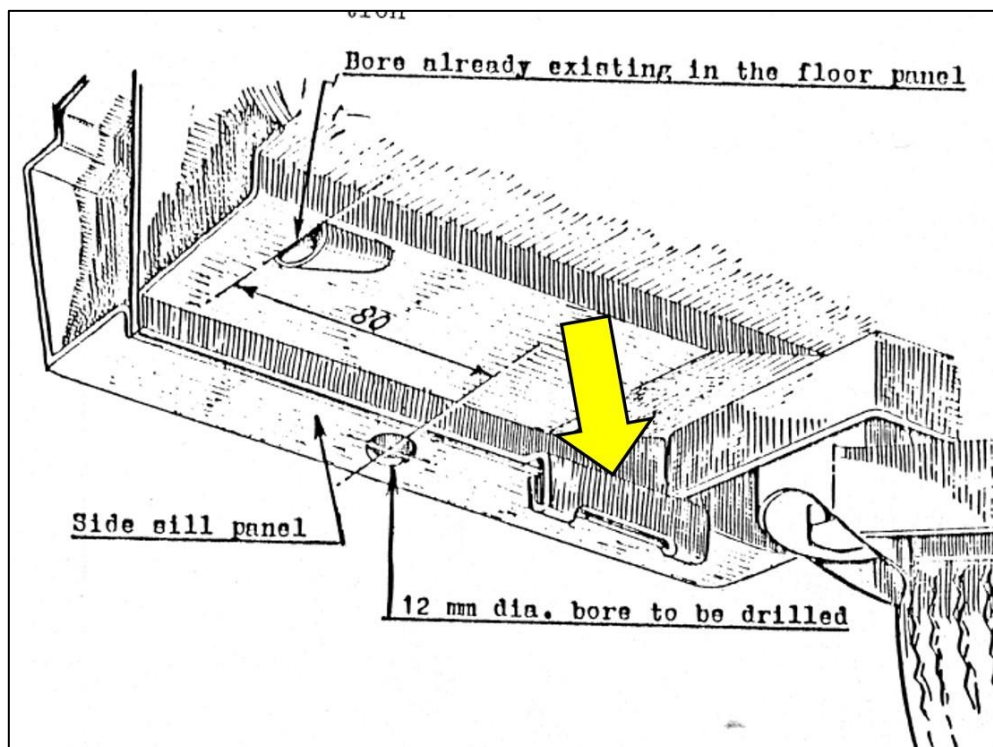
Fulvia Berlinas and some Coupes omitted the vertical plates and instead used metal frames, folded over and welded to the flange that is formed between the inner and outer sills. These are shown in the sketch below, taken from a Lancia Service Note from 1972 that also recommended the addition of a 12mm drain hole to the outer sill in this area.

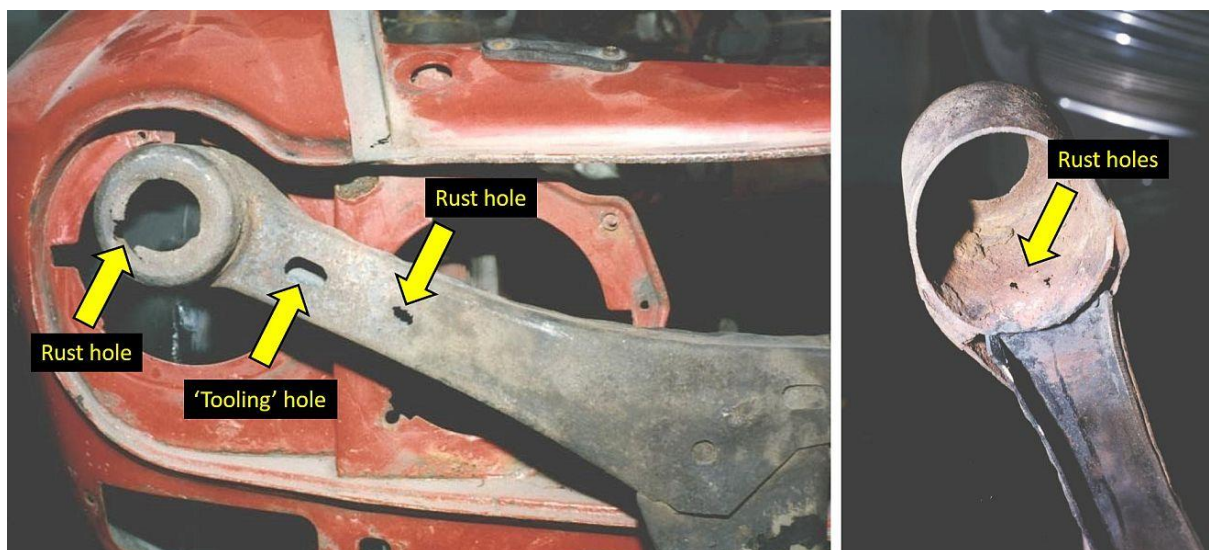
Before starting repair work on the subframe, it is advisable to make a jig with bolts that locate through the four lower mounting points on the subframe and also line up with the mounting points on the car body. The jig can be used to ensure that the correct subframe geometry is maintained during subframe repair. Once the engine and subframe have been removed and separated, the subframe should be stripped, cleaned and checked. The pictures below show a right-hand outrigger before and during its restoration in 1994.

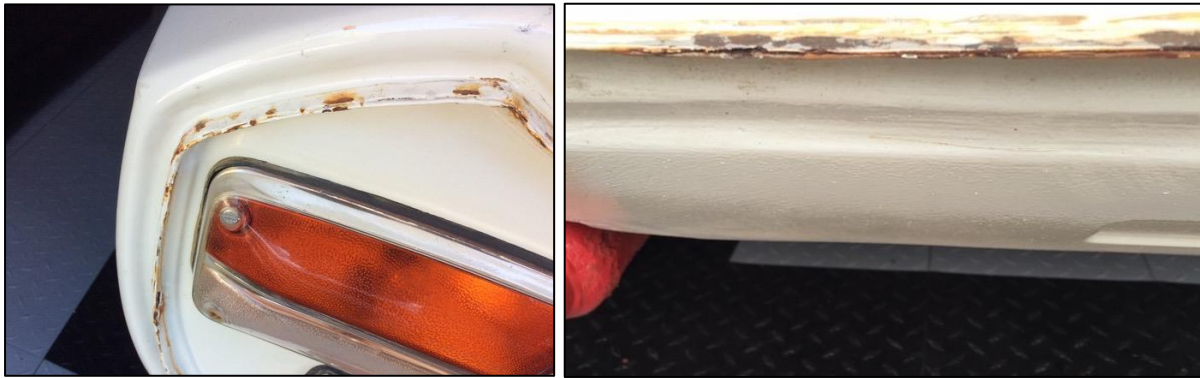
In areas where this flange joins together two sharply curved sections of bodywork, above the headlights and in the boot/trunk corners (see Section 2.1, non-critical areas 10 and 12), water which penetrates the flange can collect and cause corrosion to the surrounding panels.

Corrosion in these areas can be very hard to address if it is advanced. Removing the trim will make the extent of the problem clearer. The recommended approach to rectification is a multi-step one:

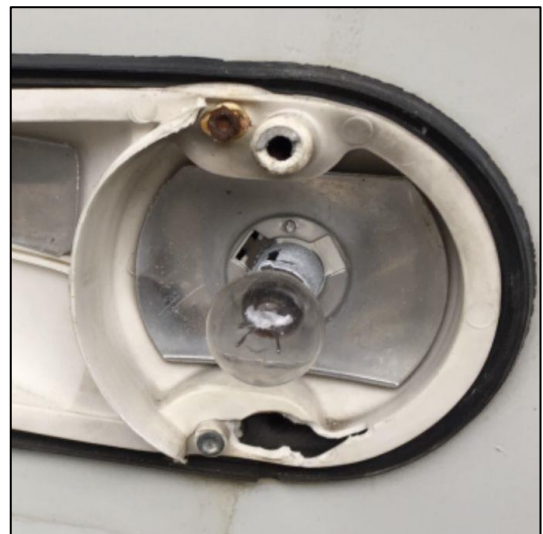
Overtightening of the four screws which join the lens to the base unit often leads to breakage of the screw cups in the lens unit and/or failure of the threaded bosses in the base unit. The screw cup in the lens can usually be repaired using a small washer inserted to reinforce or replace the base of the cup and secured using epoxy resin. Tape or superglue can be used to hold the washer in place while the epoxy resin is applied and excess resin can be removed using a blade and a small drill before the resin is fully set.

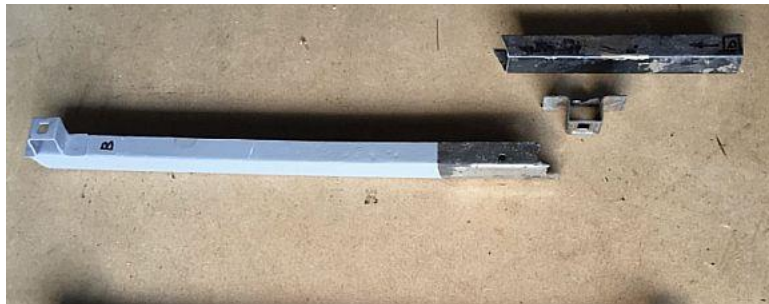
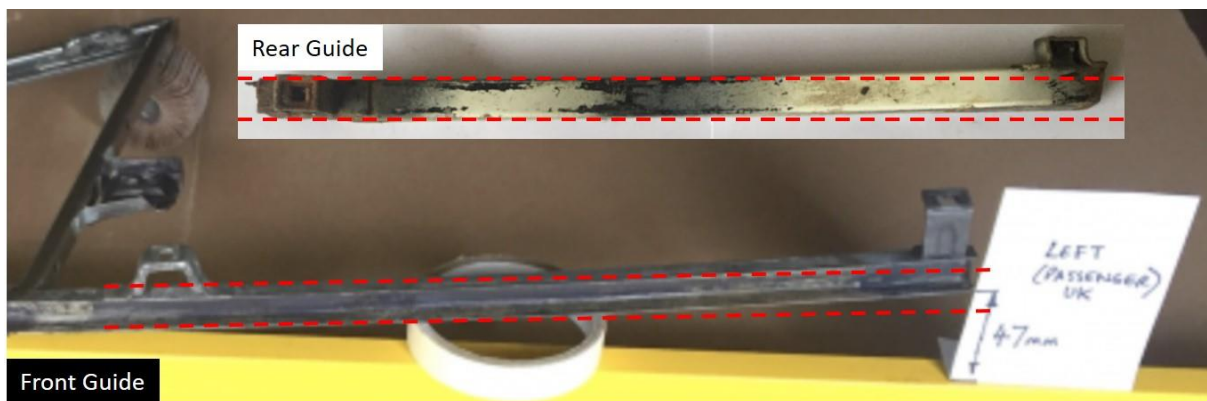
Before the repairs were carried out, it was noted that both front and rear guides have a pronounced curvature and that fabrication of a complete new guide would not be straightforward (see below). Fortunately a second-hand door guide was available whose centre section could be used to provide two shorter repair sections. These were welded in, along with the fixing brackets.
