FULVIA

COUPE
SPORT

**OWNERS NOTES:
2. RESTORATION (Part 2)**

Glyn Williams & Norm Thomas
April 2025

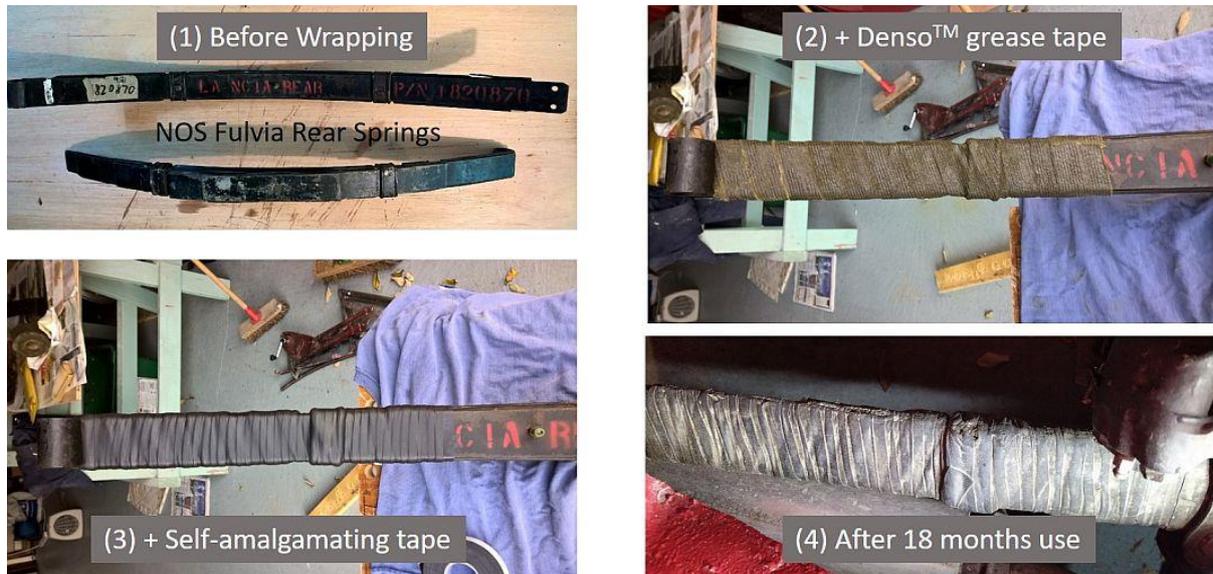
The NOS springs shown were obtained in 2020 with their factory paint and stencilling intact and so, in order to preserve this and prolong the life of the spring, some thought was given to their protection while in use. The use of spring gaiters was considered but rejected, since any failure of the seal leads to the trapping of water and enhanced, unobserved corrosion.

Instead the rear springs were first treated with a coat of proprietary spray-wax (Comma Wax Seal Spray) and then wrapped in protective grease tape (Denso Tape, 50mm wide). After that, an outer layer of rubber self-amalgamating tape was applied. The central portion of the spring which, when fitted to the car is protected by the shackle plate, was left uncovered. The springs were checked after 18 months of use and the covering was found to be intact and still flexible.

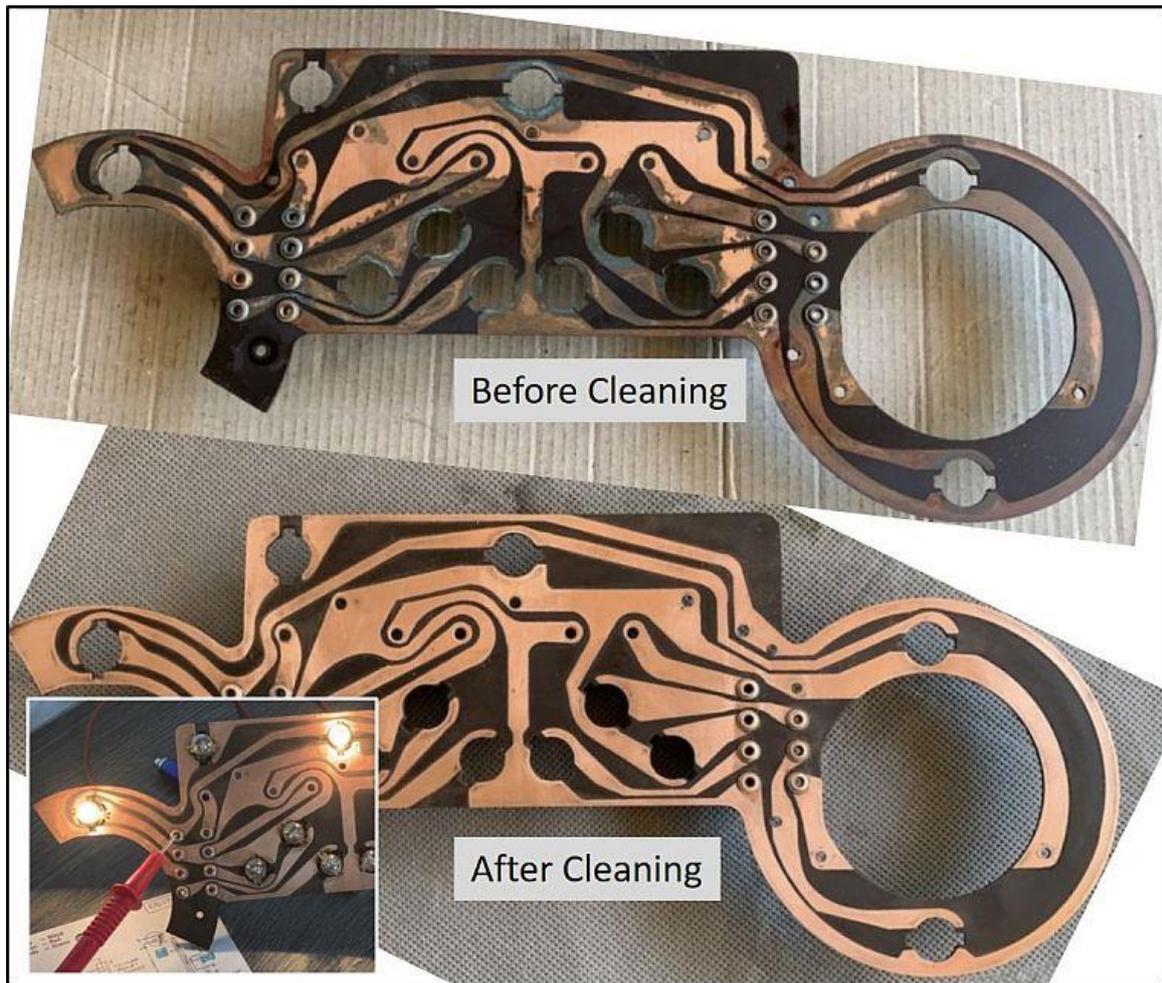
The PCB and its contacts to the instruments are subject to corrosion and so cleaning with fine emery paper or wire wool is advised. Dirty contacts can cause erratic movement and incorrect calibration of the gauges and rev counter, as well as poor illumination of the instruments. Particular attention should be given to the areas where the bulbs and gauges make contact with the boards. These contacts are visible as small holes in the PCB in the photographs below.

Before re-installation into the instrument cluster, the circuits and the 8-pin connectors on the rear of the board should be tested for continuity and excessive resistance. It is also important to check the quality of the common earth that is provided to the board by a pin on the white 8-pin connector. This is supplied, via a terminal on the white 8-pin connector, from a lead that can be traced back from the connector, but which is usually attached to the body at nut J (lower dashboard panel fixing). This earth should be checked and cleaned before reassembly.

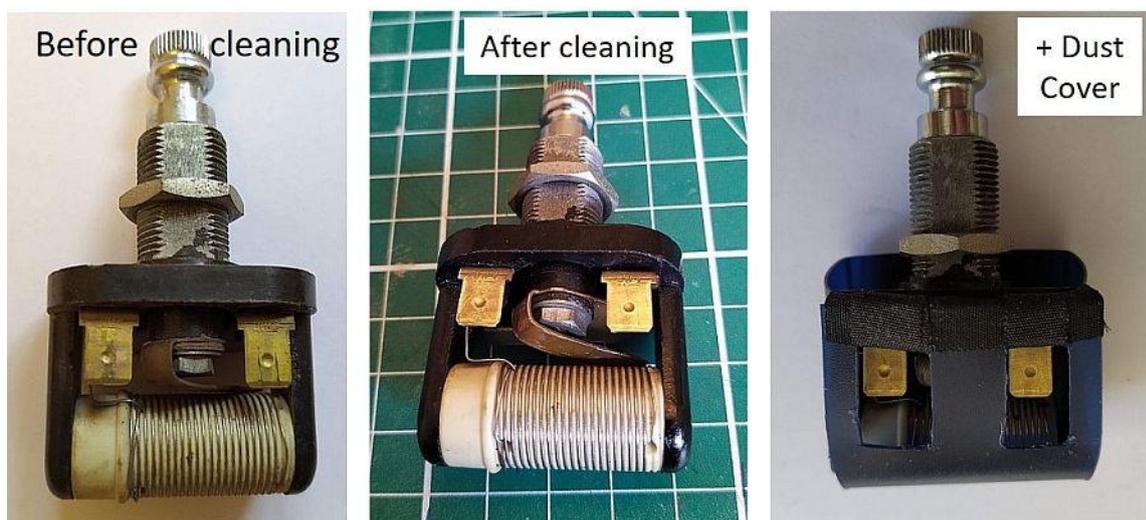
If the panel illumination was poor before refurbishment, the lighting rheostat (mounted behind the instrument panel, near the rev counter) should also be removed, tested and cleaned. Access to the rheostat is greatly improved if the rev counter (Veglia) or the instrument cluster (Jaeger) is first removed. The item supplied with the Veglia cluster is a CEAM rheostat. The wire coil and the travelling brass contact that provides a variable resistance are exposed to dust and dirt behind the dashboard and, in this case, had not been maintained in at least 40 years. After removal of the rheostat, its resistance range was measured at approximately 5Ω to 20Ω . However, during the movement of the contact, changes in resistance were not smooth and resistance readings were often unstable, suggesting that the effective contact area was very small.

After cleaning the travelling contact with emery paper and the resistance coil with solvent and switch cleaner, consistent measurements were obtained and the resistance range was re-determined to be 1.1Ω to 9.8Ω . There is no evidence that the rheostat was supplied with a protective cover to keep out dirt and dust. The final picture shows a suitable dust cover, made from flexible plastic sheet (ex-A4 document folder). The rheostat should be re-installed with the wiring and contacts (shown below) on the bottom.

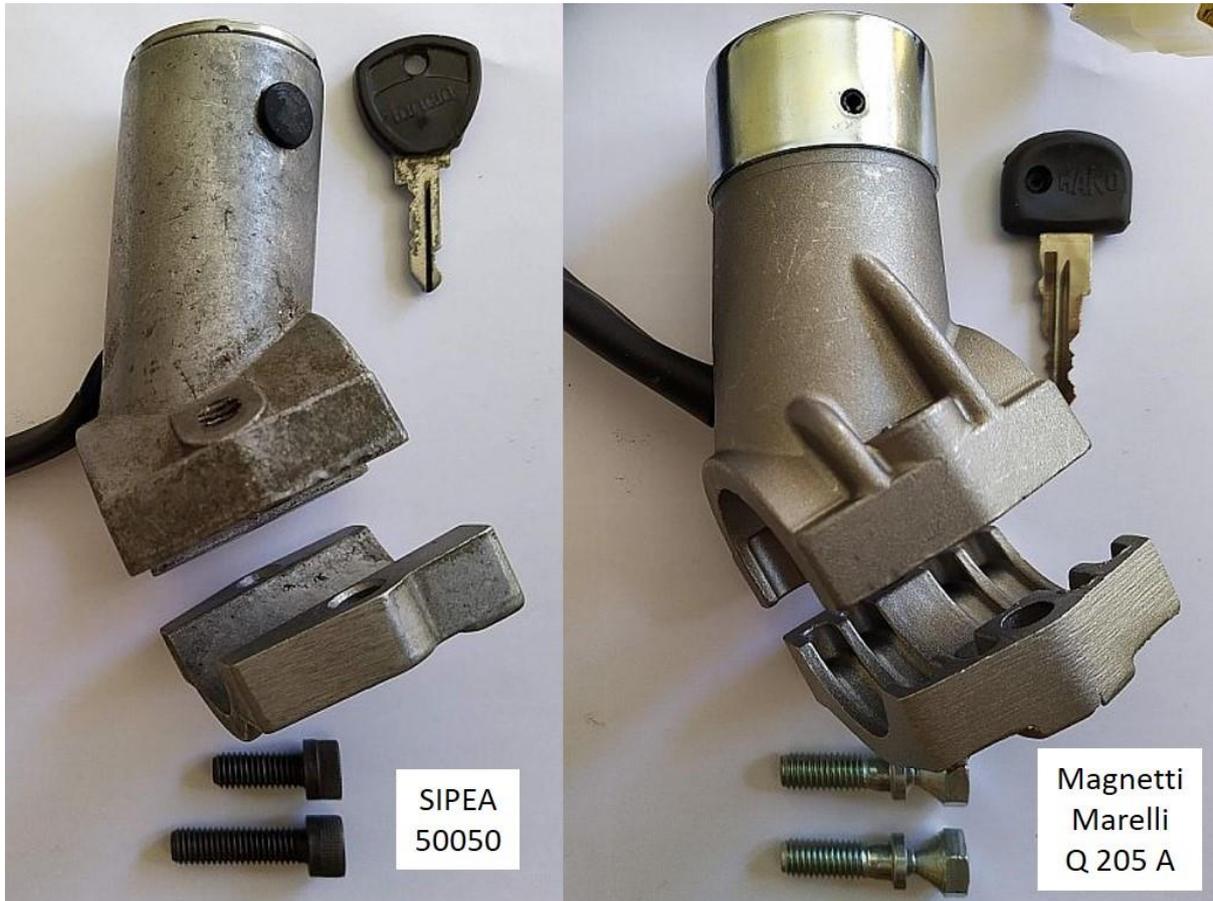
Other ignition switches, by Magnetti Marelli, were certainly supplied with shear-head bolts and an example is shown below, alongside the refurbished SIPEA item.

The SIPEA switch has a steel pin inserted through a hole in the shroud which engages with the inner barrel. It has been suggested that, after removing two short screws that attach the inner barrel to the shroud and withdrawing the key when the lock is in the GAR position, the pin can be pushed down allowing the barrel to be removed. However, possibly due to previous damage to the pin, this pin could not be depressed and so the decision was taken to drill it out. A pillar-drill was used to reduce the upper section of the pin until the lock barrel was free to move, while taking care not to damage it. Before reassembly, the hole in the shroud was drilled out to 8mm and covered with a small silicone bung (see photo above).

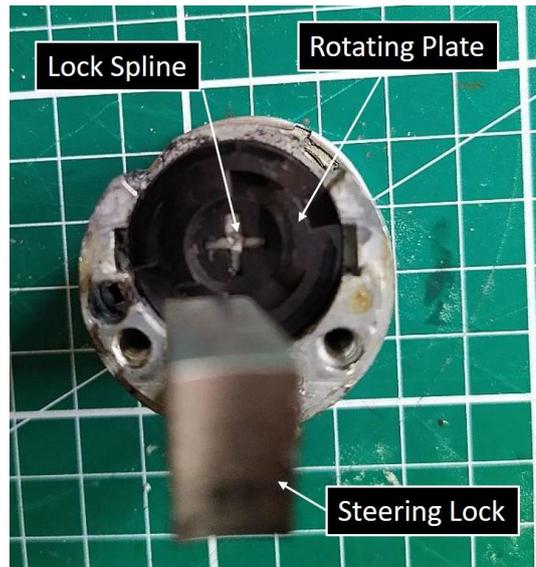
Finally, the rotating plate, mounted on a spline projecting from the barrel lock, is shown below. The plate has various ramps and projections which press on the push-rods to open selected contacts as the key is rotated. Since, in the absence of pressure, the contacts are closed, excessive wear on the plate or the push-rods would be manifested as inappropriate activation of ignition-controlled circuits. However, this does not seem to be an issue in Fulvias yet, even with lock switches that are more than 50 years old.
