FULVIA

2nd SERIES

COUPE
SPORT

**OWNERS NOTES:
2. RESTORATION**

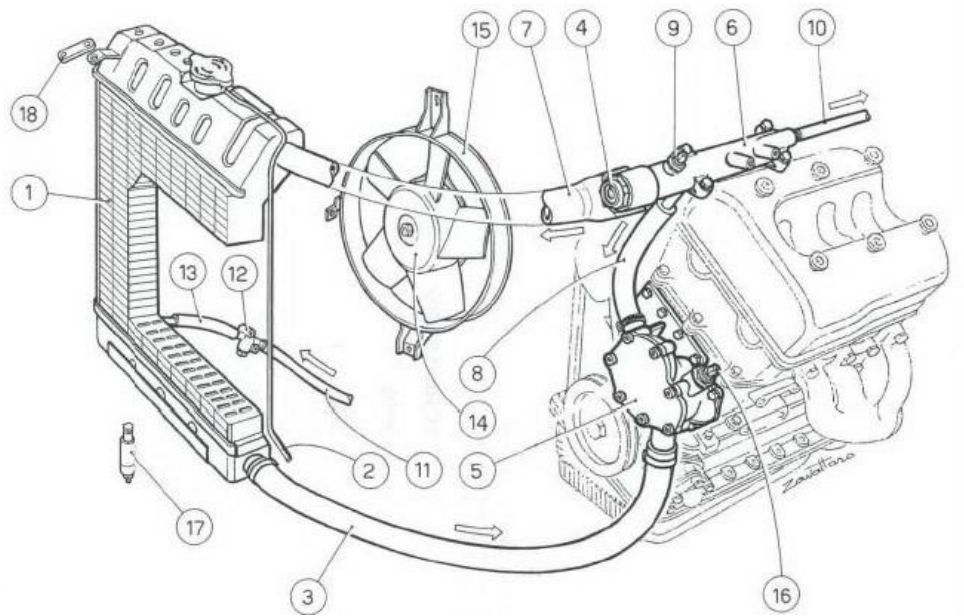
| 1. Radiator | 2. Overflow hose | 3. Bottom Hose (Radiator Outlet) |
| 4. Thermostat | 5. Coolant Pump | 6. Coolant Rail (Engine Outlet) |
| 7. Top Hose (Radiator Inlet) | 8. Bypass Hose | 9. Temperature Gauge Transmitter |
| 10. Heater Supply Hose | 11. Heater Outlet Hose | 12. Drain connector & Plug |
| 13. Radiator Drain hose | 14. Electric Fan | 15. Fan Shroud |
| 16. Fan Control Thermo-switch | 17. Lower Mounting | 18. Upper strap |

The cooling system consists of a Radiator (1) containing a reservoir of coolant. The coolant is drawn through the Bottom Hose (3) and into the engine via a Pump (5). Coolant exits the pump through a hole in the rear face of the pump and is distributed to channels at the bottom of the engine block. In normal running, when the thermostat (4) is open, coolant is pumped to the top of the engine assisted by convection as it warms. At the top of the engine, hot coolant exits through two channels in the intake manifold where it collects in the Coolant Rail (6). From here hot coolant returns to the radiator via the Top Hose (7) or some may pass into the cabin heater via the heater supply hose. To permit limited coolant circulation when the engine is cold and the thermostat is closed, a small proportion also re-enters the pump via the bypass hose (8) where it is sent back into the engine.

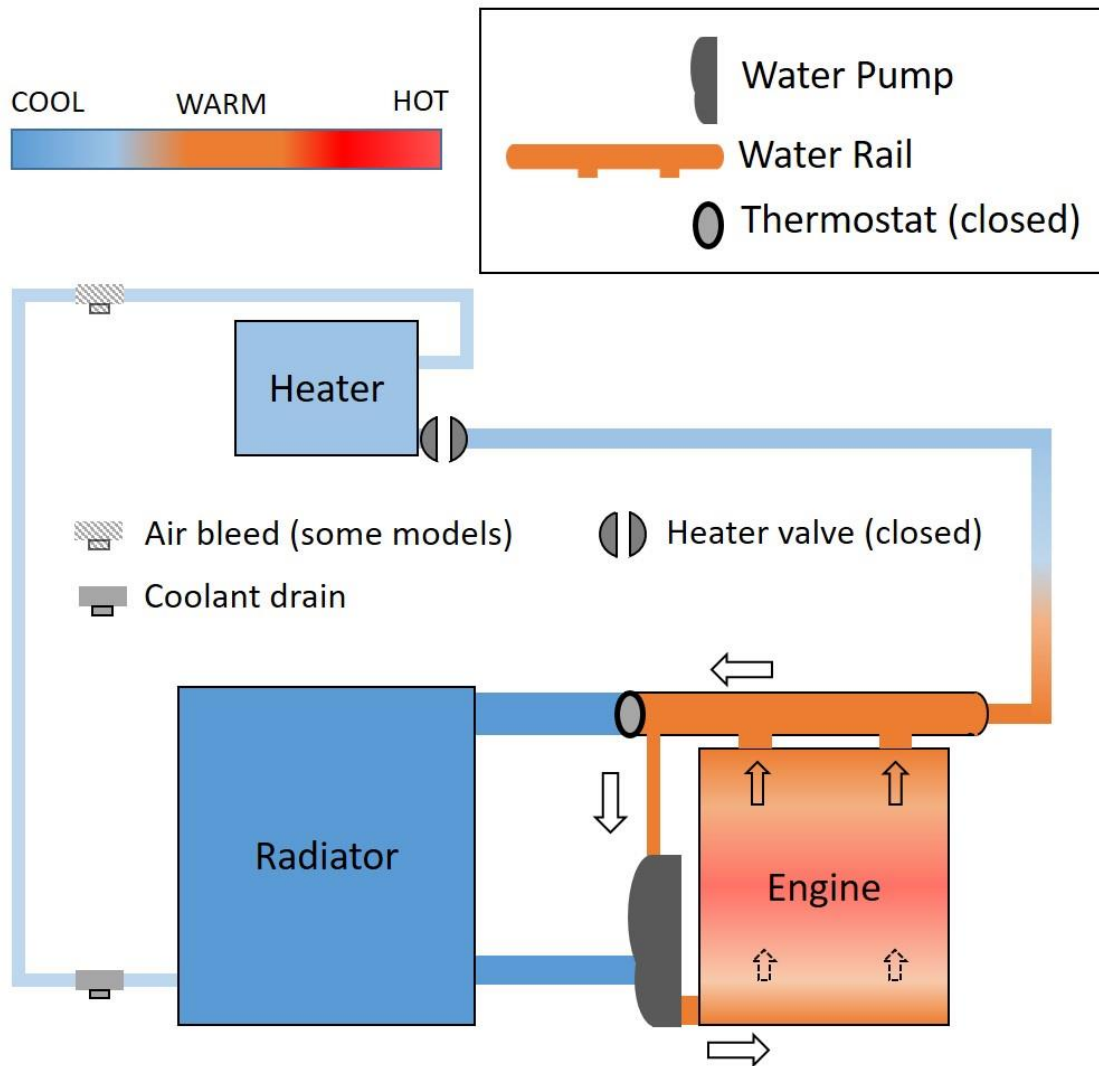
A third outlet from the water rail, the bypass hose, allows some hot coolant to re-enter the water pump, where it is immediately pumped back into the engine. Although this slightly reduces the cooling efficiency of the system, the presence of the bypass hose protects the pump from excessive back pressure when the engine is cold and both the thermostat and cabin heater valves are closed. By allowing coolant to circulate around the engine while it is warming up, the bypass hose also reduces temperature gradients and hotspots in the engine (see diagram below).

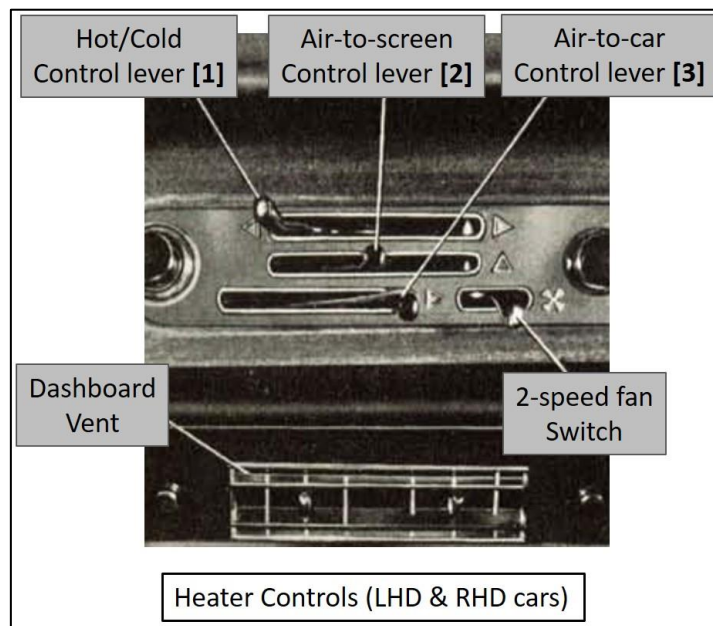
Three levers control the coolant and air flow through the heater core and its vents (see figure below). These levers should all operate smoothly and without requiring excessive force. Typically, problems arise with the operation of the Hot/Cold control lever [1] which is connected to a mechanical valve mounted on the side of the heater box, in the passenger foot well. Common problems with the heater controls are (a) levers that are stiff or jammed, (b) the shaped ends of levers have broken off, often in an attempt to overcome jammed or stiff operation, and (c) no hot air can be obtained due to failure of the water valve or the operation of control rods and cables.

Lever [1] is connected, via a Push-Pull cable and a hinged plate, to two control rods which are mounted on the side of the heater. These are accessed from the passenger foot-well (the left side in right-hand-drive cars). One of the rods opens and closes the external valve, controlling coolant flow, while the other rod opens and closes an internal flap within the heater box, allowing air to flow upwards through the heater core.

Levers [2] and [3] are connected, again via Push-Pull cables, to hinged couplings that act directly on flaps within the heater box. These flaps control the air flows that are directed to the windscreen [2] and to the dashboard vent [3]. Unlike the heater valve, the locations of these flaps and their couplings are the same for both LHD and RHD cars. The cable of lever [2] is attached to a coupling on the upper left-hand side of the heater box while that of lever [3] attaches to its upper right-hand side.

Corrosion and scale build-up in the heater valve introduces resistance to lever [1] and can lead to kinking of the control cable. Problems with the free movement of the internal flaps are less common, but all levers will be affected if the various metal, plastic and felt washers that are contained within the heater controls have corroded or decayed (see later for their removal).

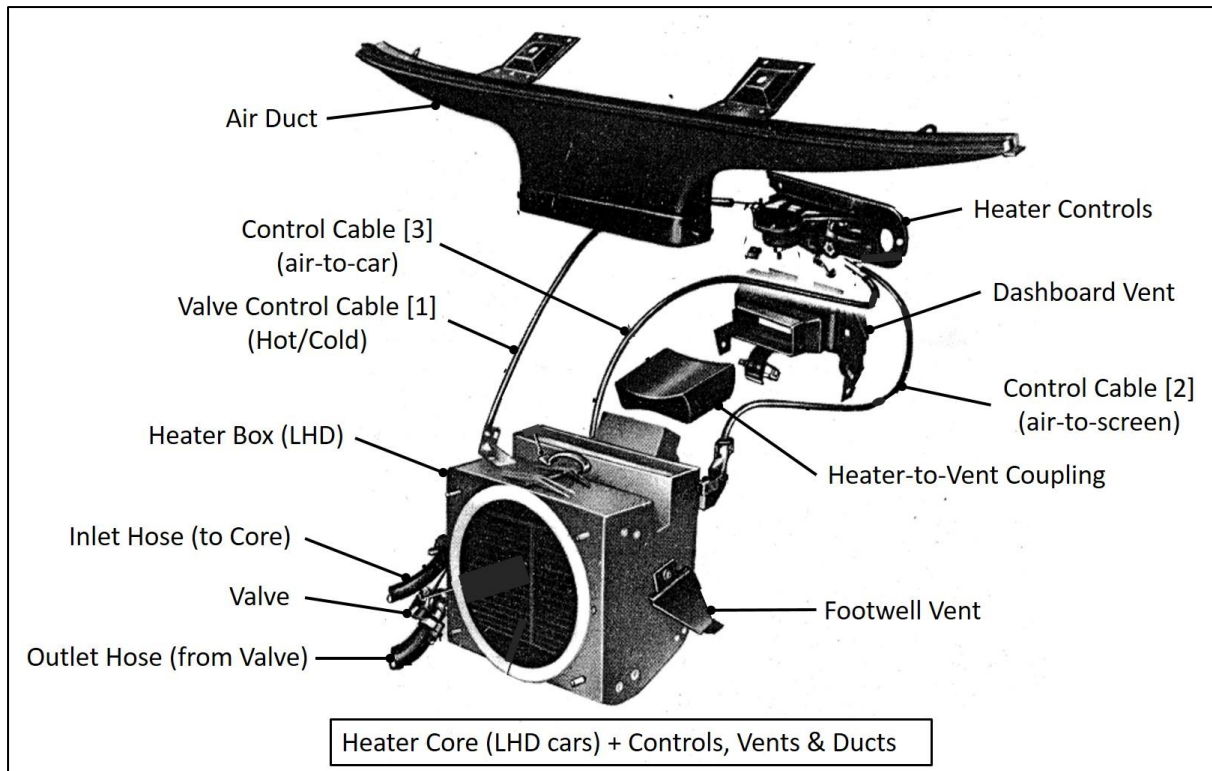
If damaged, the control cables will need to be removed and repaired or replaced. Since many of the cable fixings are hidden behind the dashboard and the lower panels, it is necessary to start by removing the dashboard and dashboard top, as described above. It is also recommended to remove some or all of the lower panels, particularly the panel below the glovebox, to improve visibility and access. Before going further, we recommend a study all the available diagrams of the heating system, contained in the Lancia Parts Manual, some of which are reproduced here.

* Note that the Heater Inlet, Outlet, Valve and Control Cable [1] are present on the opposite side in RHD cars [adapted from the Lancia Parts Manual]

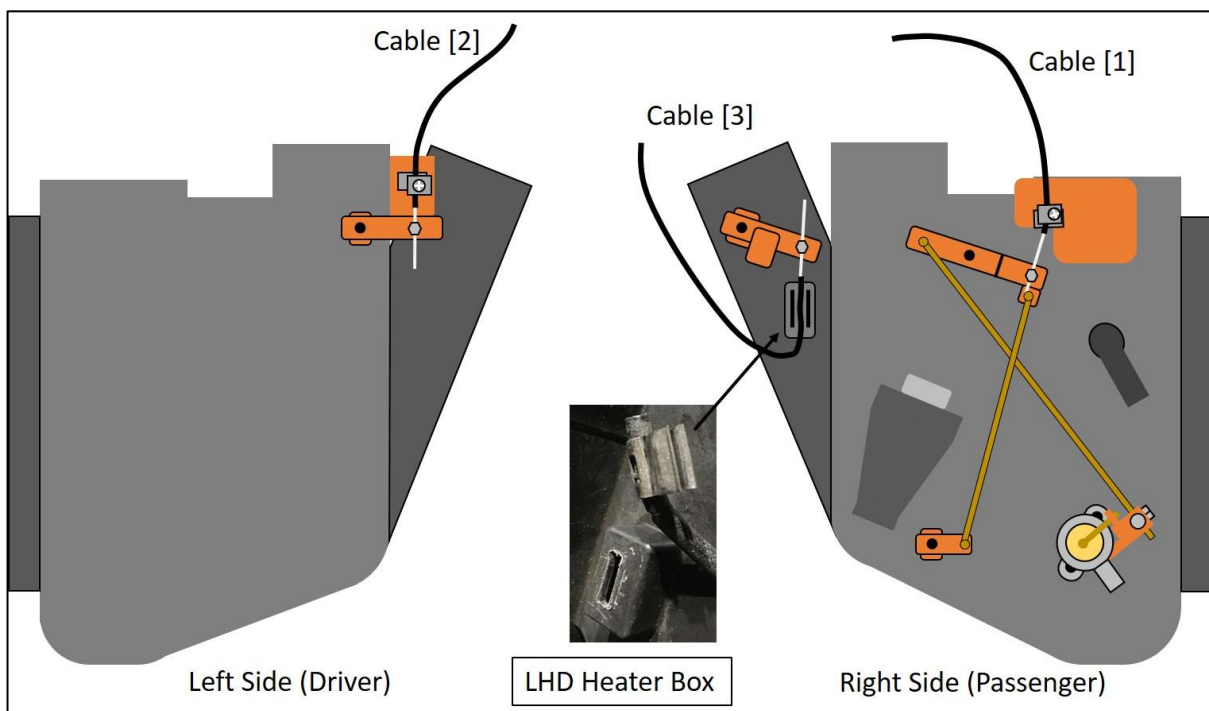
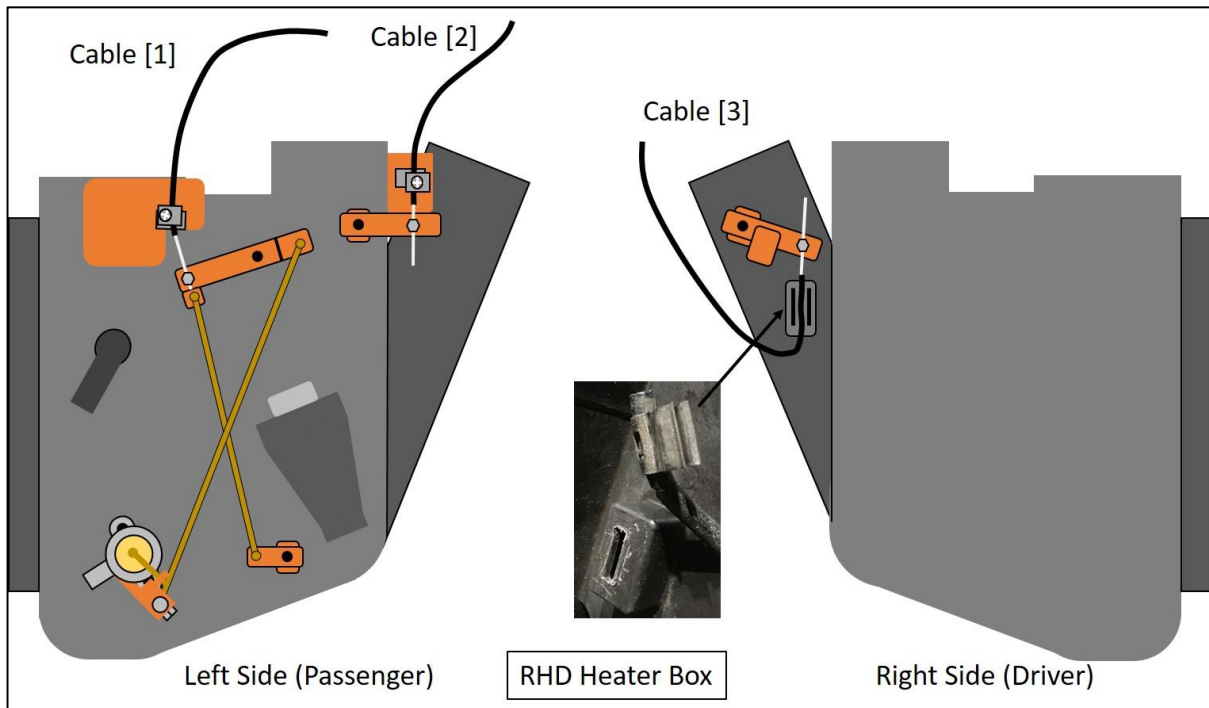
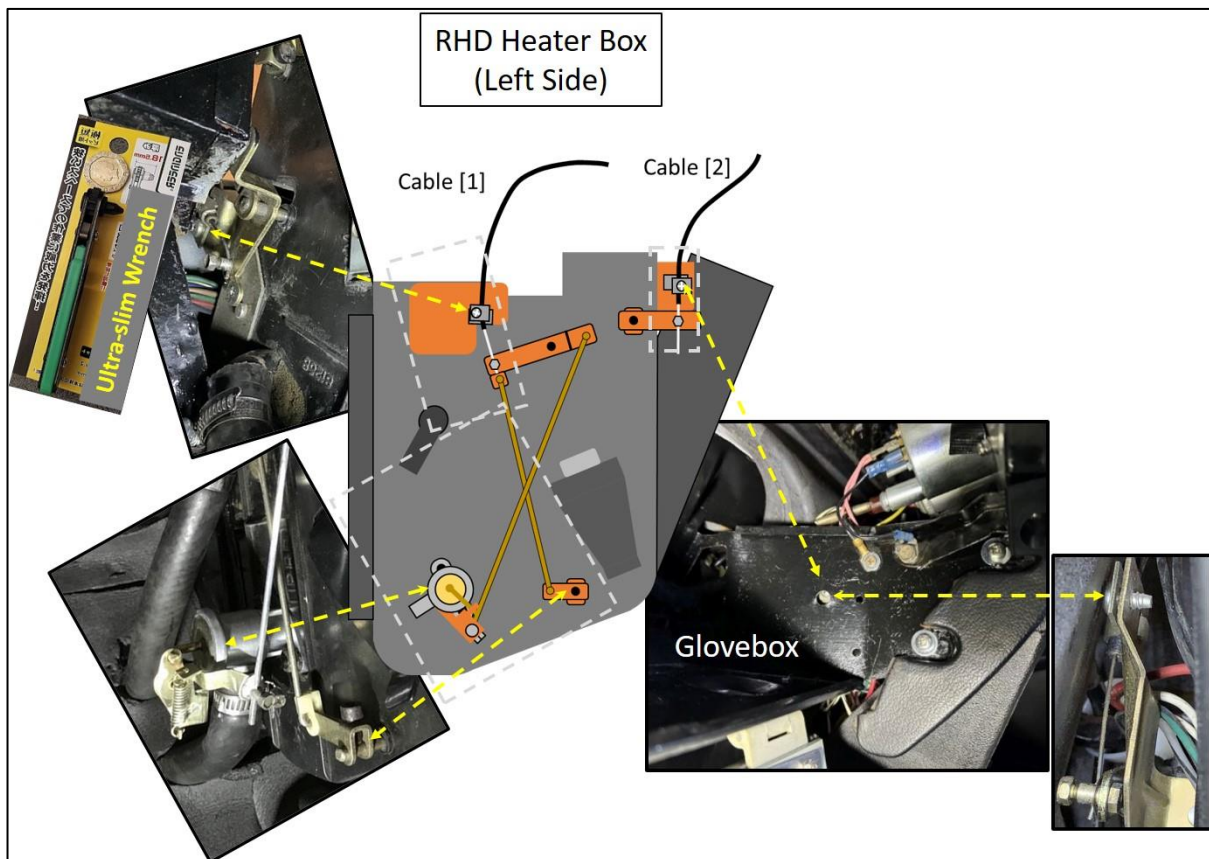
Simplified cartoons of LHD and RHD heater boxes and the points of attachments of their cables are shown below:

Each cable fixing has separate clamps for its sheath and its wire core. For both LHD and RHD cars, access to these clamps is more difficult on the passenger side, being restricted by the proximity of the side of the glovebox. The wire of cables [1] and [2] are gripped by machine screws and can be disconnected using a thin open-ended spanner; however their sheath clamps are secured using small Phillips screws which require the use of a short angled screwdriver or an ultra-thin wrench with a Phillips hex bit. This is particularly problematic for cable [2], whose bracket projects away from the heater box, bringing the screw head very close to the side of the glovebox in RHD cars. In some cars, this screw can be accessed via a small hole in the side of the glovebox. If this hole is not already present, it may be necessary to estimate the position of the screw and drill one ($\phi = 6\text{-}8\text{mm}$).

The clamps of cable [3] are mounted on the right-hand side of the heater vent chimney, which is connected, via a rubber coupling, to the dashboard vent. This chimney is narrower than the heater box itself, leaving significantly more space to access the clamps, even on LHD cars where the glovebox lies on this side. In contrast to cables [1] and [2], the sheath clamp of cable [3] consists of a barrel-shaped metal clip whose edges push into slots on a moulding on the vent chimney. This clip can be removed by compressing the barrel using a pair of needle-nosed pliers, while gently pulling it away from the heater. When all three cables connected to the heater box have been freed from their clamps, attention can turn to extracting the heater controls from the instrument panel.

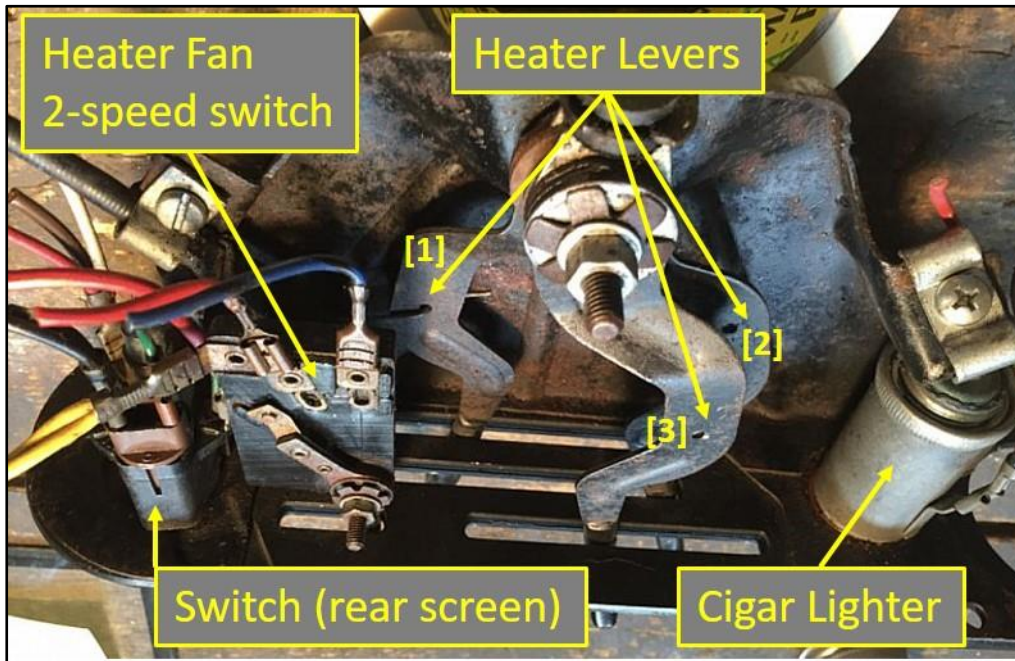
An unrestored heater control unit, viewed from behind and underneath in its orientation in the dashboard, is shown below.

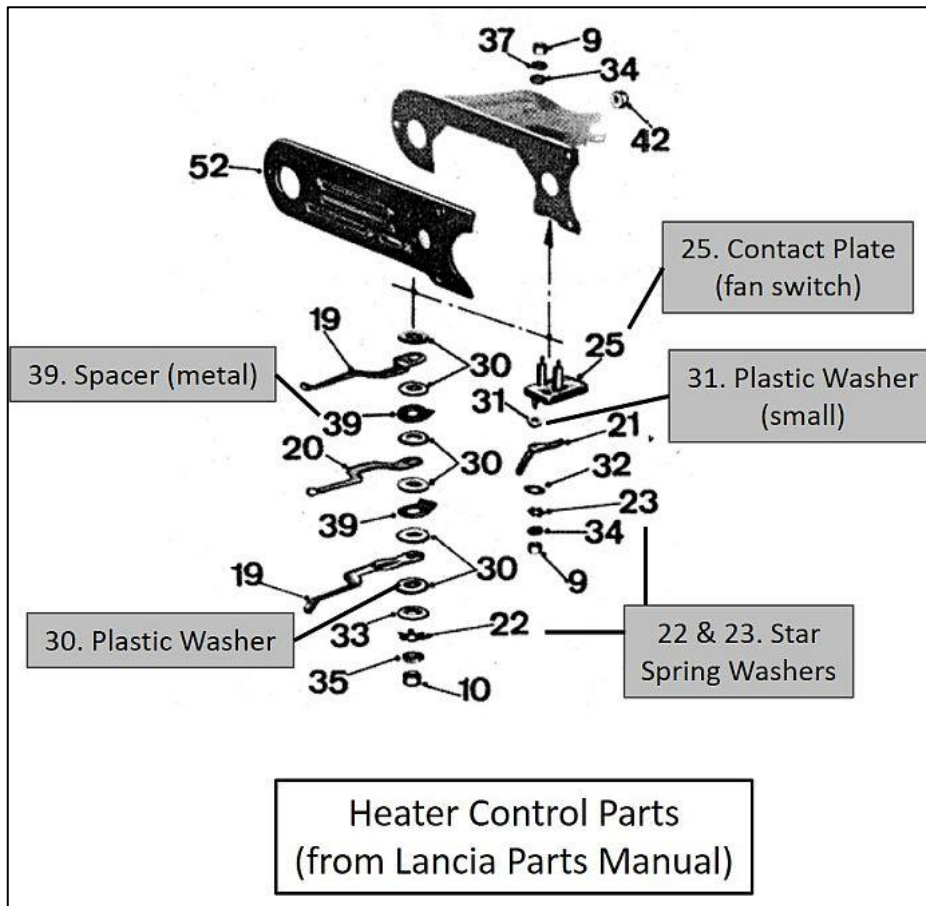
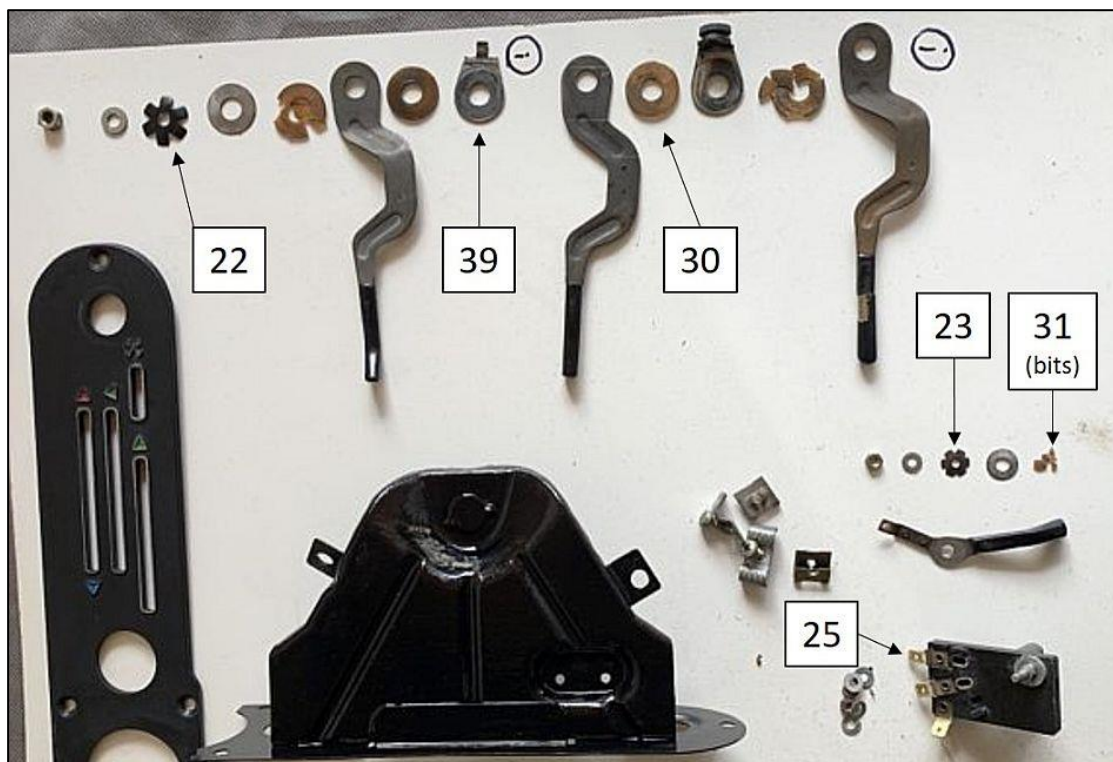
Note also that Lever 1 (item [19] below) is inverted, relative to Levers 2 and 3. This orientation is correct and should be maintained when reassembled, as shown in the official Lancia diagram, adapted from the 1970 Parts Manual (TAV 85a).

Once the control unit and fascia panel have been removed, dismantling on the bench is straightforward. Note that the control levers and the fan switch must be removed, and replaced, as a unit with the fascia panel since the lever ends are too large to pass through the slots in the panel. Dismantling of the levers therefore starts (and reassembly ends) with the central bolt. The levers are separated and cushioned by an array of flexible plastic washers, spring washers and spacers, some of which may be broken or brittle after 50 years of service. Suitable plastic washers can be obtained from Omicron in the UK and should be replaced as a matter of course. Replacements for damaged or missing lever ends are also available, as are complete levers.

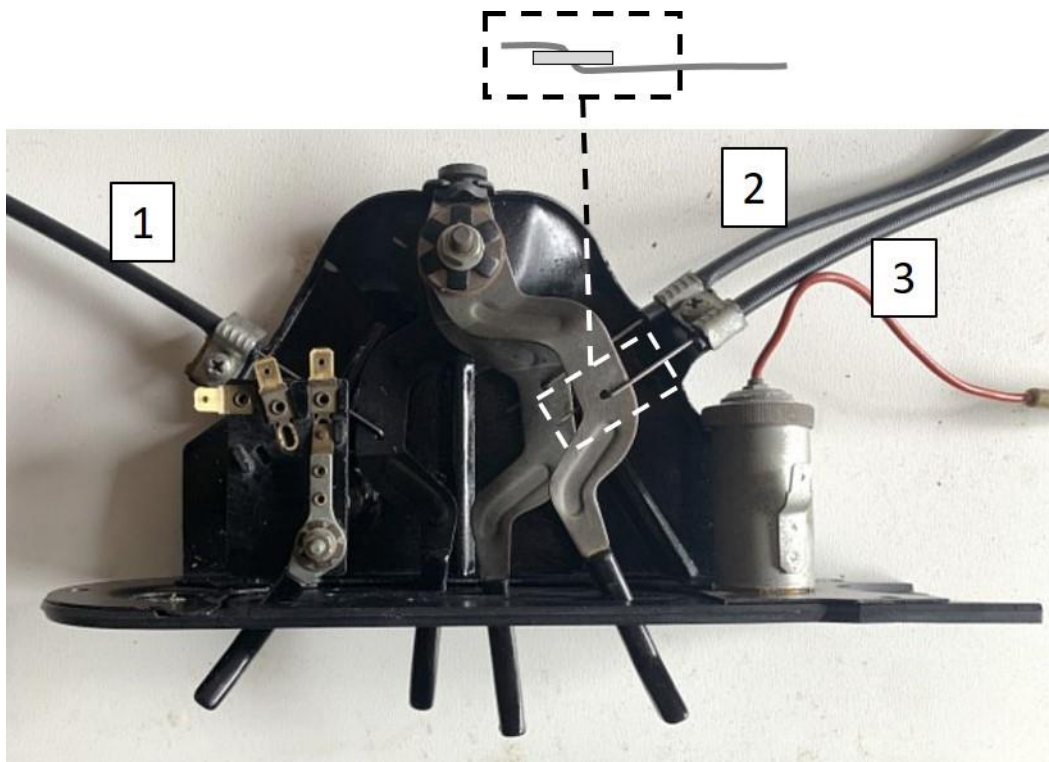
When replacing cables, the wire ends which attach to the lever need to be stepped appropriately, by bending. The stepped end is then passed through a small hole in the lever ('under-and-over'), after which the cable sheath can be secured using a clamp attached to the mounting plate. Once secured, the step in the wire prevents it from being withdrawn through the hole in the lever. This arrangement leaves the control wire close to the surface of its lever on both sides and also unable to rotate, preventing the cable end from interfering with other levers or the mounting plate during operation of the heater. Replacement wires can be obtained from Omicron Engineering in the UK (<https://omicron.uk.com/>) and are supplied with their ends pre-shaped.

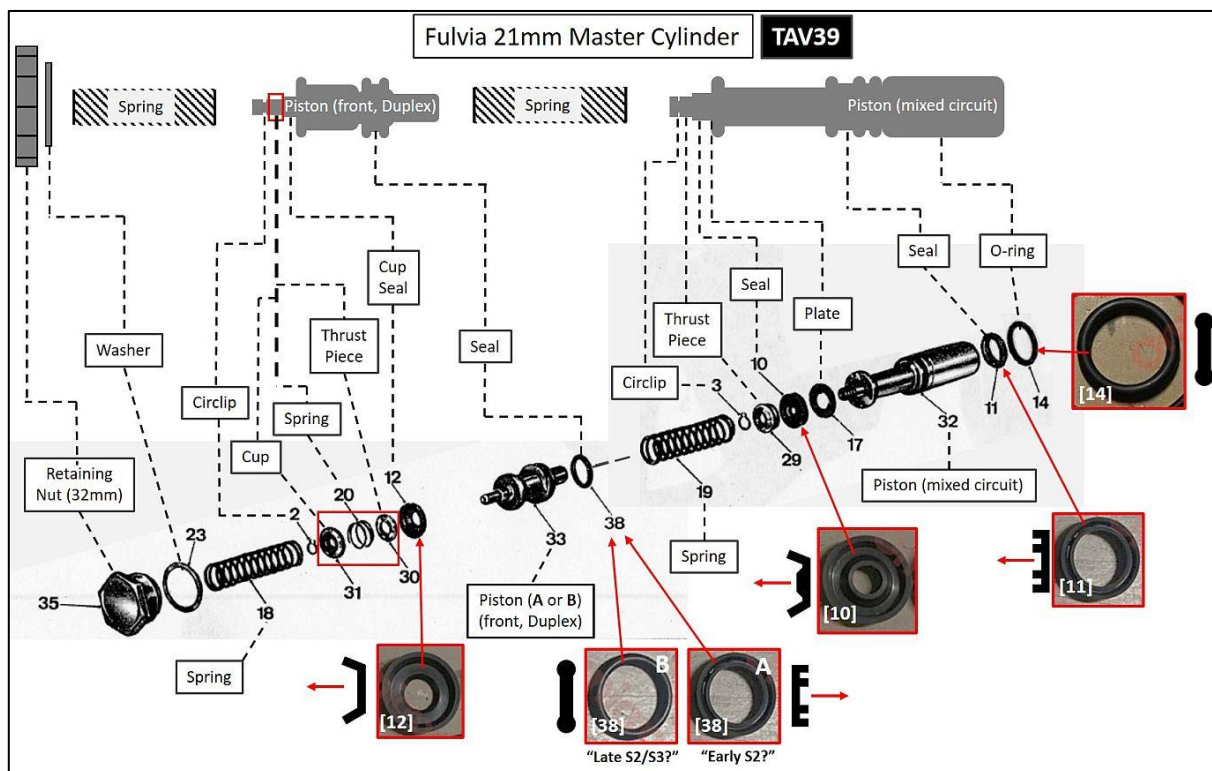
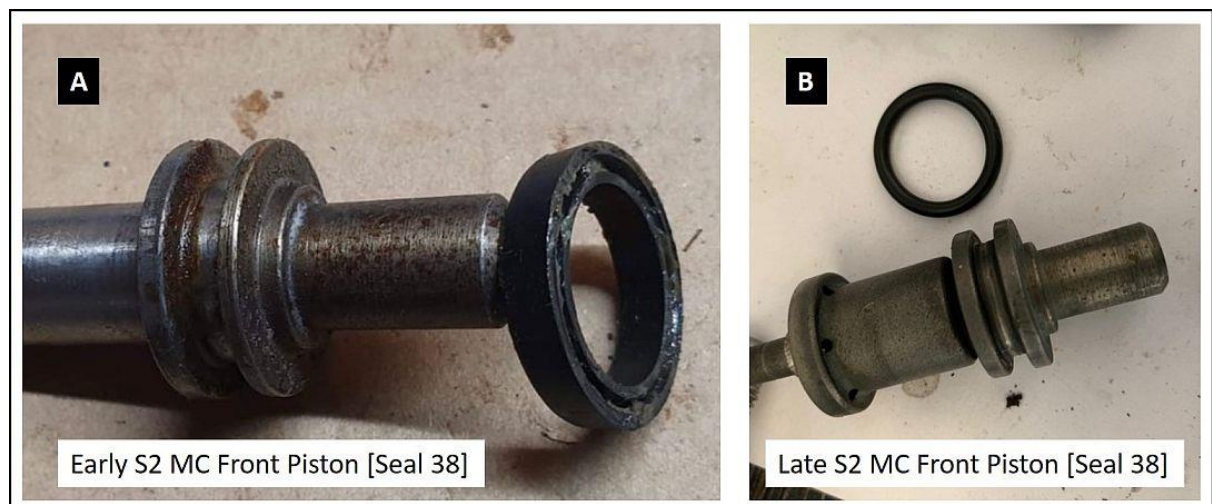
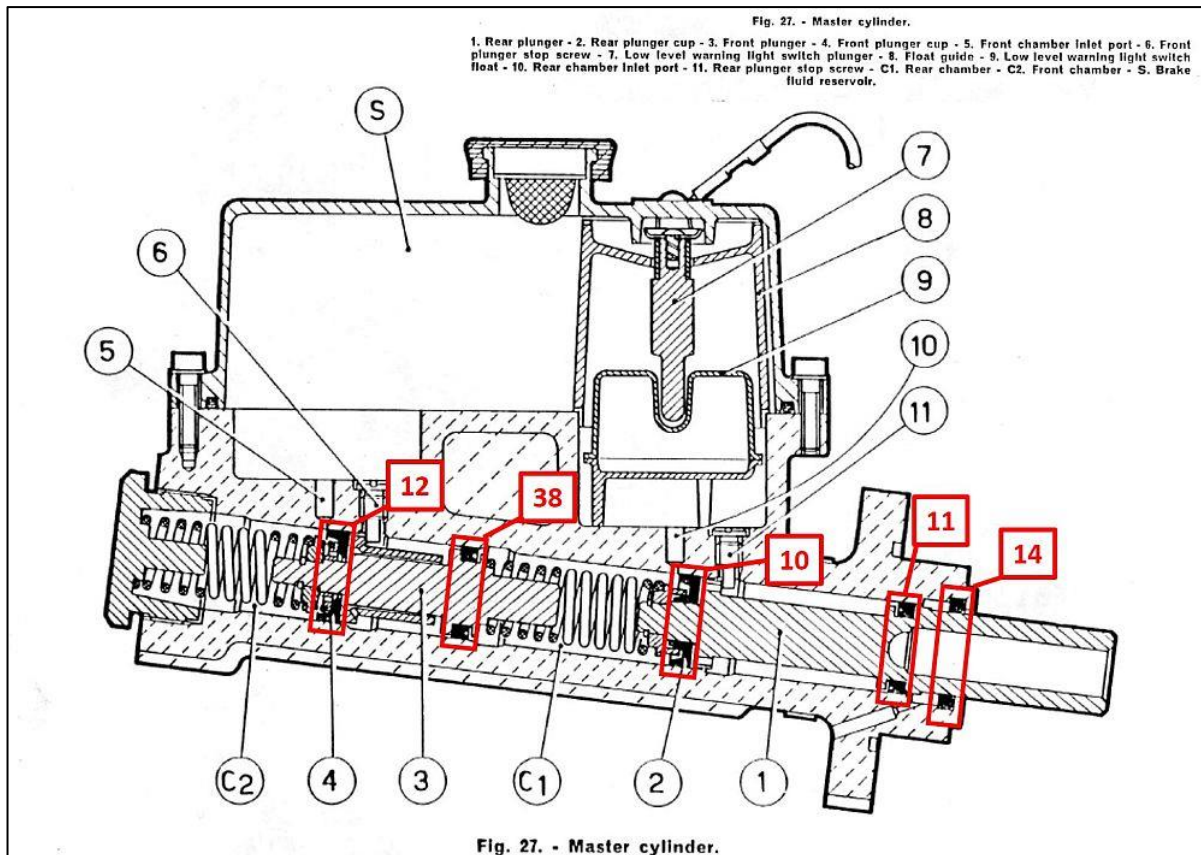
Annotated diagrams, taken from the Fulvia Workshop Manual and the Lancia Parts Manual 1970 showing the construction of the 21mm Master Cylinder are given below. The positions of the rubber seals are shown by red boxes and numbered according to their designations in TAV39 of the Parts Manual. While it is not apparent in this diagram or stated in the manuals, it is important to note

that Lancia used two versions of the front piston, which differed in the style and dimensions of their rear seals (item **[38]** in the diagram), during the production of the S2 & Fulvia3 Series Coupes. Both options should be supplied in S2/Fulvia3 seal replacement kits. However, it is important to note which type is present when dismantling, and refit the correct one (also, do not be concerned that you have an additional seal left over after rebuilding). Earlier cars used a double concentric seal, identical to seal **[11]** but facing in the opposite direction, while later cars had a narrower groove in the front piston and used a circular-sectioned O-ring.

Information contained in Footnote B from later editions of TAV39 indicates that this change was made in 1973, after chassis numbers 22720 (Coupe) and 3547 (HF Coupe). Note also that a second, slightly larger O-ring **[14]** is present on all cars and inserts into a groove in the barrel of the master cylinder near its end (see the Master Cylinder cross-section, below).

The pistons, springs, seals and other internal items can be withdrawn after removing the large retaining nut at the front of the master cylinder. This nut has a fine thread and is usually held fast by a small amount of alloy corrosion. Hold the master cylinder in a vice and use a 32mm socket with a breaker bar or an impact driver to break the seal. Exercise caution while unscrewing the nut, since it is held under some pressure by the internal springs. Once the nut has been removed, push the pistons and their springs out carefully, noting the order of the parts and the arrangements of the thrust pieces, before removing the circlips and dismantling the pistons and seals. Label the springs to ensure that they go back in the order that they were removed; the front spring should be slightly shorter than the rear spring.

The front piston is more complex than the rear, in particular, its arrangement of cup, spring and thrust piece, which sit in front of the cup seal, must be able to slide freely on the piston. Before reinstalling the master cylinder on the car, fill the reservoir with brake fluid and press the rear plunger repeatedly until fluid is expelled from the front and rear outlets. In order to limit the amount of air in the system prior to bleeding, first refill the reservoir, then fit the master cylinder to the brake servo and bleed the brakes (mixed circuit, rear - mixed circuit, front – duplex, front and repeat). It may also be advisable to wait for 24 hours before testing the car. Some combinations of aftermarket brake seals and brake fluids have been known to swell with time, with the result that the master cylinder locks, and so the operation of the brakes should always be re-checked before driving on the road.

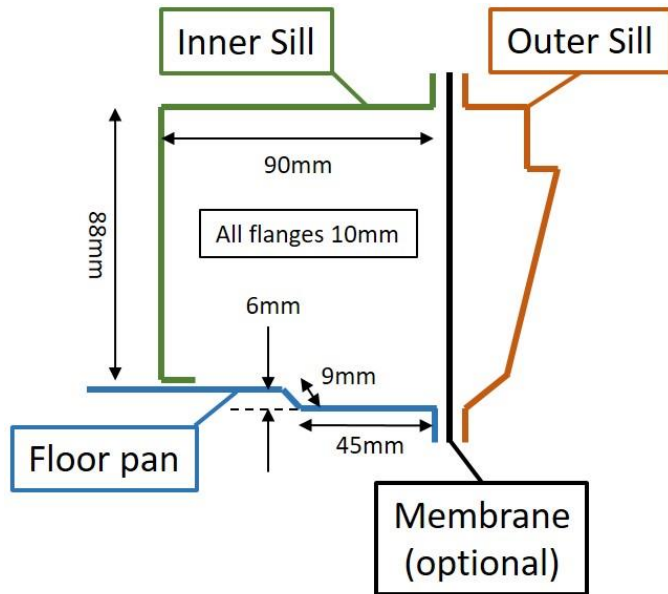
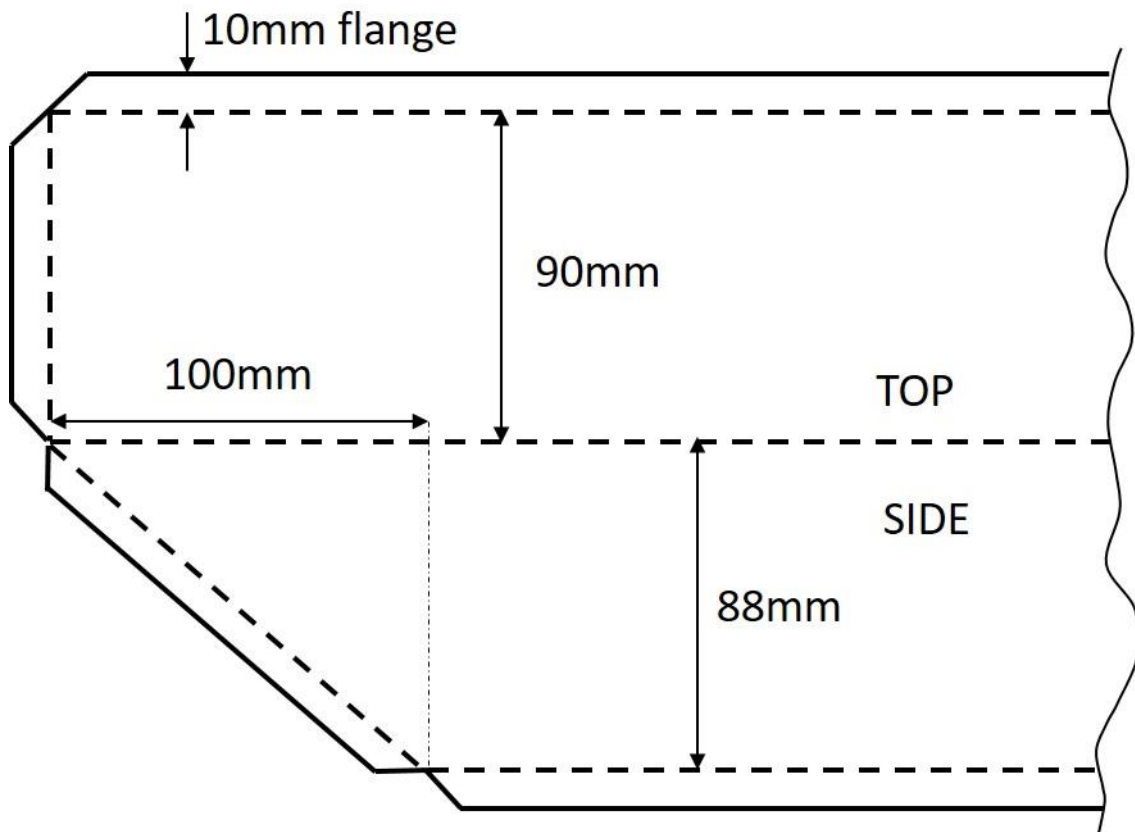
Appendix 1. Inner Sill Cutting Plan & Folding

Inner Sill Pattern (front)

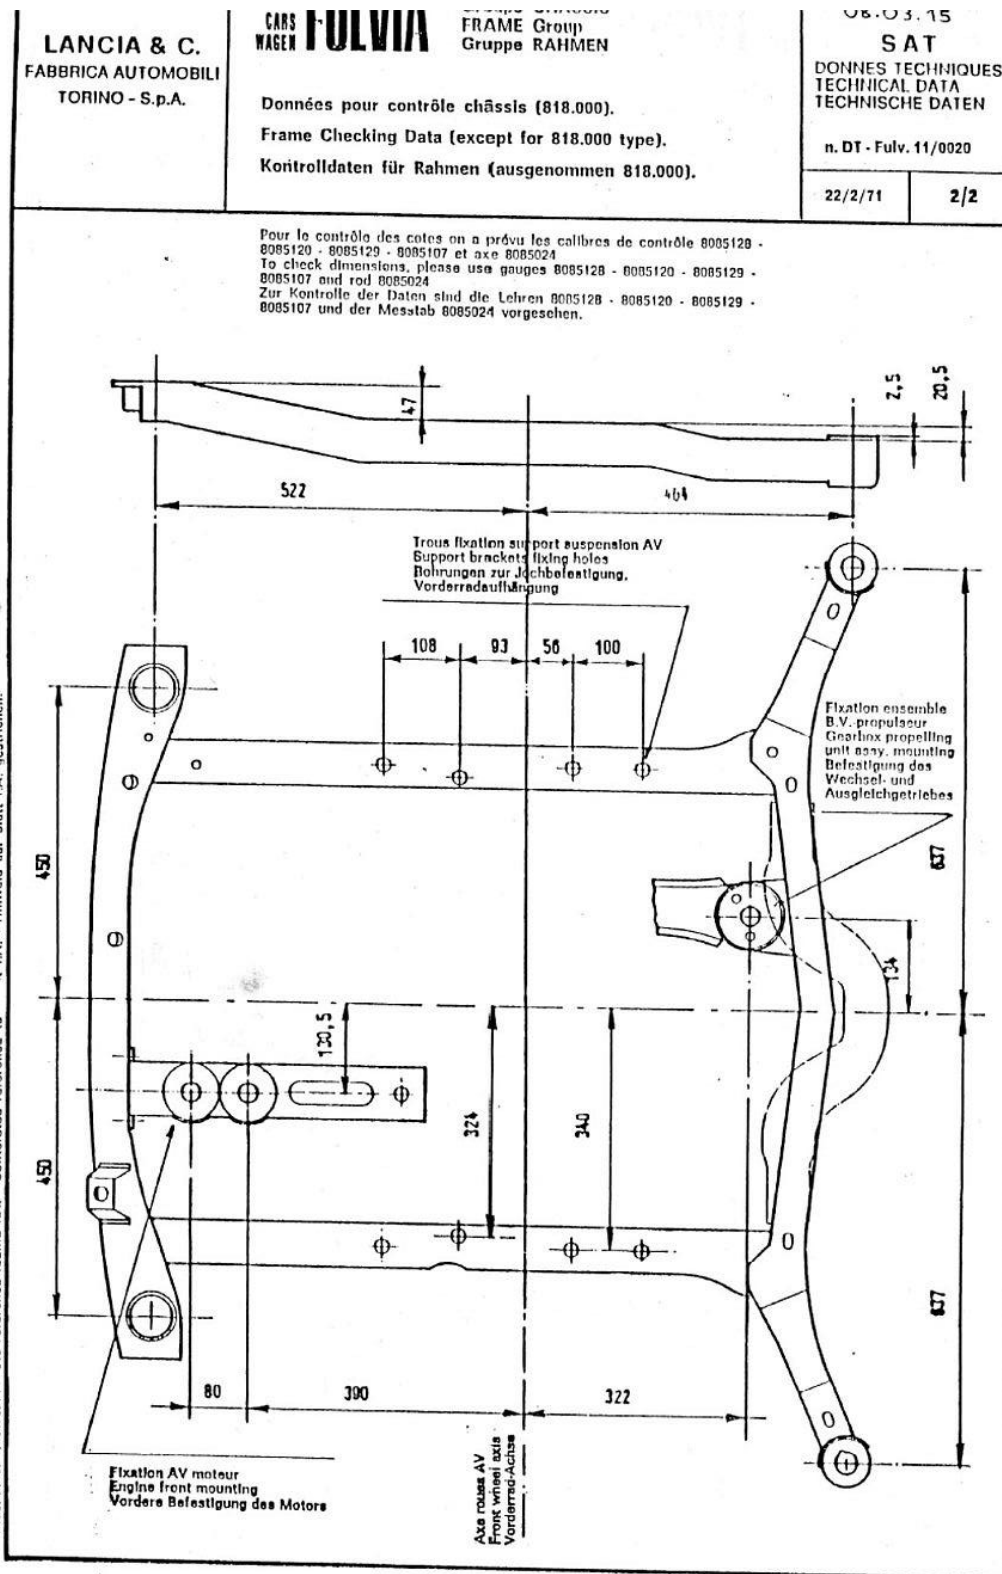
Appendix 7. Front Subframe Dimensions & Chassis Reference Points

Subframe Dimensions for All Fulvia Types,
except 818.000 (Berlina 1.1)
