FULVIA

2nd SERIES

COUPE
SPORT

**OWNERS NOTES:
2. RESTORATION (Part 1)**

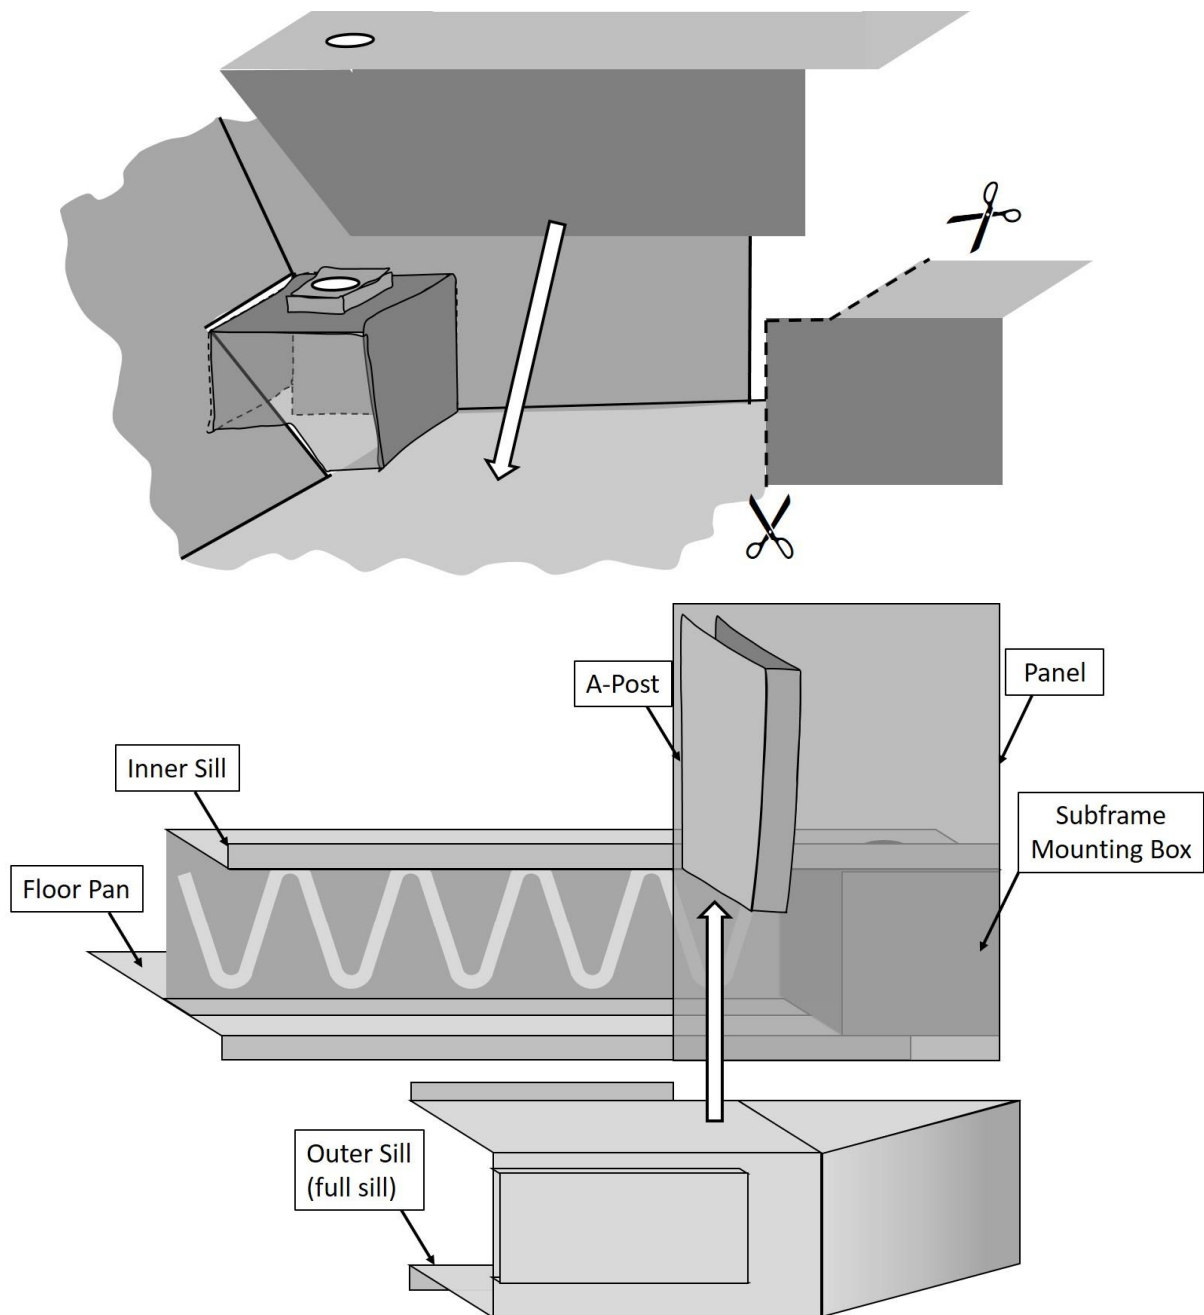
In the case of the 1600HF (above right), the outer sill extension and the area of the panel around the subframe mounting box, as well as the box itself, were badly corroded or missing. A previous repair in this area had consisted of connecting the floor to one of the remaining faces of the box using a strip of bent metal, leaving little support for the A-post.

The drawings below show the proper arrangement of the Inner Sill, floor pan and the rear Subframe Mounting Box, viewed from the right-hand foot-well and, separately, from the outside of the car. When removing the front section of the inner sill, the horizontal and vertical cuts can be offset as shown, to provide greater strength when a new section is welded in.

It is currently possible to purchase full-length Outer Sills, Subframe Mounting Boxes and repair sections for the Inner Sills. These are well-made and contain all the pressings that are required for an authentic finish. An inner sill repair section from Lancia Classic (<https://www.lanciaclassic.com/>), is shown below.

While professionally-made repair panels are usually accurately made and easy to fit, their use for all corroded sections will substantially add to the cost of a current restoration. As an alternative, a self-fabricated section of the inner sill and floor can be made using the cutting plan and dimensions shown in Appendix 1.

In 1994 many items were not available, and so sections of the Inner and Outer Sill, as well as the Subframe Mounting Box, were made by hand. This proved relatively straightforward and permitted the use of thicker steel ($\phi = 1.5\text{mm}$, 16-17 SWG) to make a fully sealed, tapered box to support the A-Post. This restoration option is shown in Appendix 2, along with cutting plans for the A-post support box. A cutting plan for the Subframe Mounting Box is given in Appendix 3.

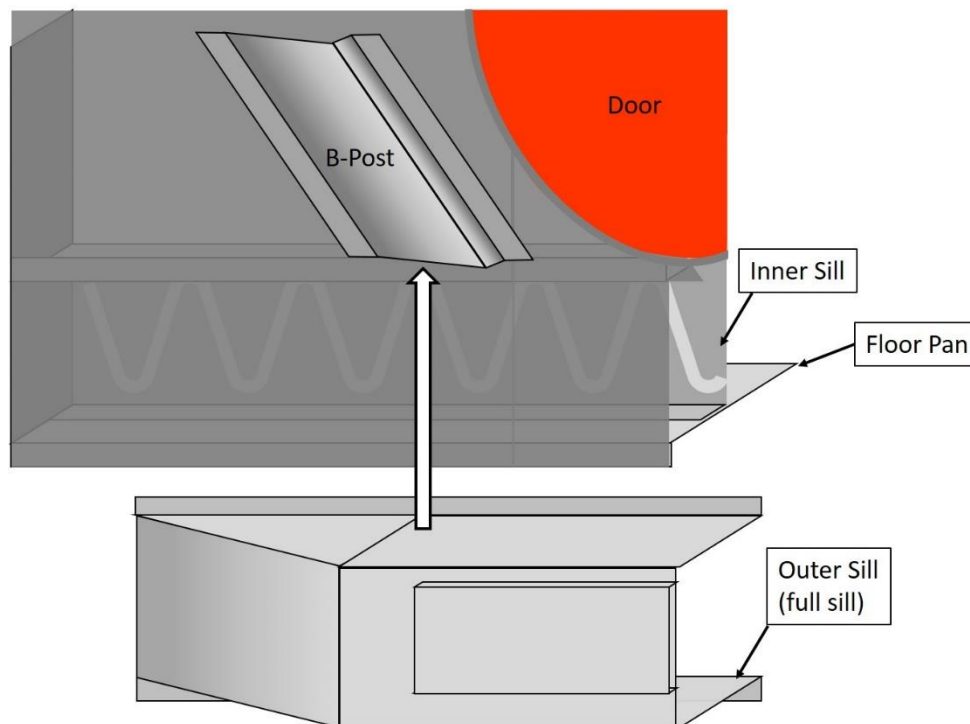
After removal of a section of the 1600HF rear wing, at the front of the rear wheel arch, severe corrosion was also found in this area of the sill. This wheel arch showed signs of earlier repairs and the extension at the end of the outer sill that forms the B-post support was no longer connected to the rest of the outer sill. The lower section of the B-post panel was also corroded, with no connection to the floor.

The proper arrangement of the sill and B-post panel is shown below.

As with the front of the sill, the unavailability of full length sills in 1994 led to the decision to make a sealed box that could support the B-post using 1.5mm (16-17SWG) steel. This was then joined to the available sill repair section, which did not have an extension at its end. Although requiring extra fabrication, this separation provides an additional barrier to the movement of water inside the sill and has proved to be resistant to corrosion for over 25 years. Details of the arrangement and fabrication plans are given in Appendix 4.

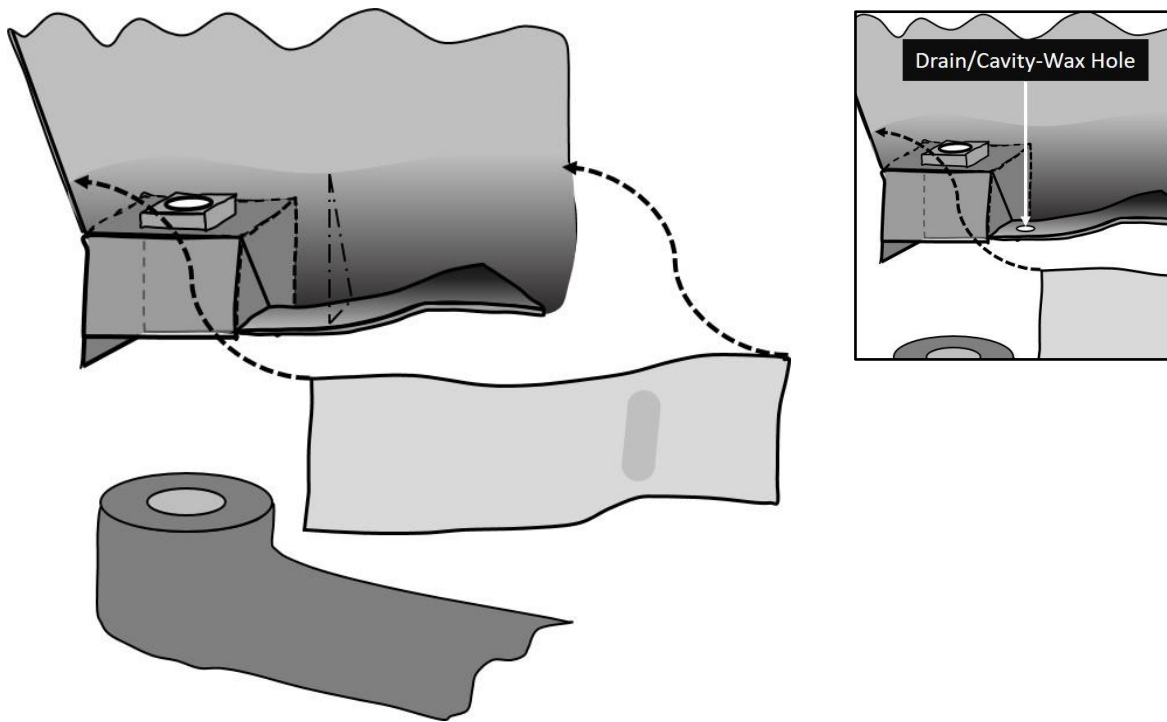
At the junctions between the foot wells and the inner wheel arches lie triangular-sectioned boxes which provide torsional strength to the body. The front portions of the subframe mounting boxes lie within these triangular boxes; the right-hand triangular box is shown schematically below.

Since the box has been formed between the outside of the car and the bulkhead, water can enter the box either through gaps in the welds along the edges of the external cover plate or via the inner sill and its junction with the bulkhead. Corrosion of the inner sill, subframe mounting box and triangular box are therefore linked and all should be checked in the event of failure of one of them.

It is advisable to add a drain hole/cavity-waxing point at the lowest part of this box, near the subframe mounting box (see inset). This can be used to protect the inside of the box and then sealed with a grommet in normal use. Templates for making replacement sections of this box are given in Appendix 5. If replacing this box, the use of thicker steel than standard is recommended for use as the outer plate (1.2-1.4mm, 17-18 SWG).

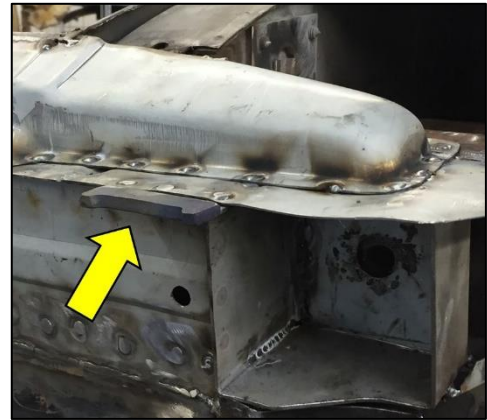
A second set of four jacking points are formed by vertical plates that insert into the weld gap between the inner and outer sills (see arrow, right), near the under-sill jacking plates. While the plates themselves are sufficiently thick to resist corrosion, the sills in these areas are particularly susceptible. Additional measures (cavity wax protection, reinforced sill membrane etc.) should be taken when replacing them.

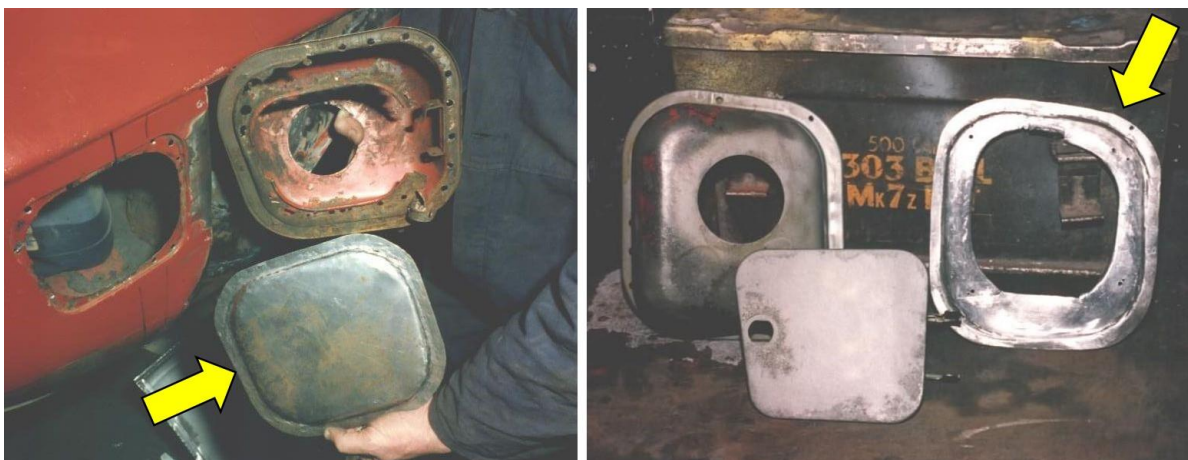
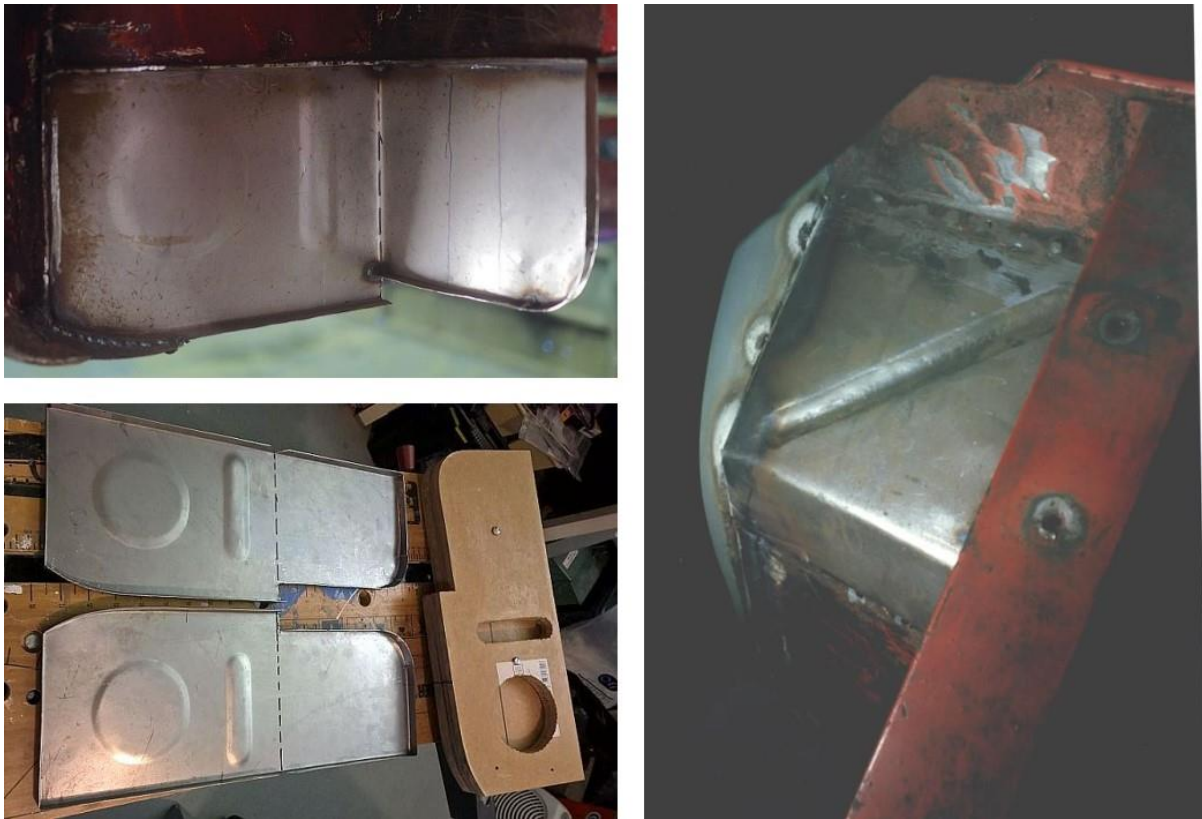
Panels that needed to be fabricated by hand during the restoration of the S2 1600HF included the face-plate of the fuel filler box, both front wheel arch lower splash panels and the right-hand inner arch upper front panel.

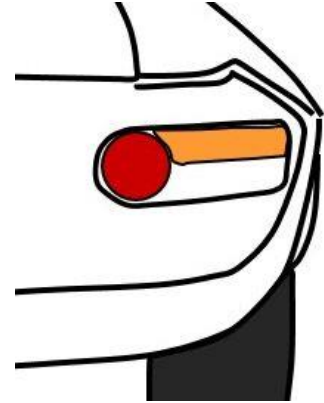
The Fulvia rear light clusters are unique to the model and suffer from the typical issues of breakage, internal corrosion and fading/loss of silvering of the plastic parts.

While remanufactured replacements are becoming available, good second hand parts, particularly the beige plastic bases, are hard to find and may be no better than those they are bought to replace. In addition, the colour of the indicator lens seems to have varied from orange to yellow over the lifetime of the Fulvia, and so a satisfactory result may require replacing both lenses from the same source.

To reduce costs and preserve originality, renovation of the existing base units can be carried out, requiring only basic skills. Both the base unit and lens can be safely cleaned in warm water & detergent, before drying. The bulb contacts and spade terminals should be cleaned with emery paper and/or fine wire wool. Wires should be replaced if the insulation is cracked or the wires show signs of corrosion or damage, using the correct wire colours to avoid future confusion.

If the indicator lens colours are faded, bulbs can be replaced with orange LEDs. There is a good case for investing in LEDs for the reversing and brake warning lights also. These should be brighter and will draw less current than filament bulbs. Provided the lenses are clean, the rear indicator and warning lights should be as bright as those of a modern car, so reducing the chances of a rear end collision.

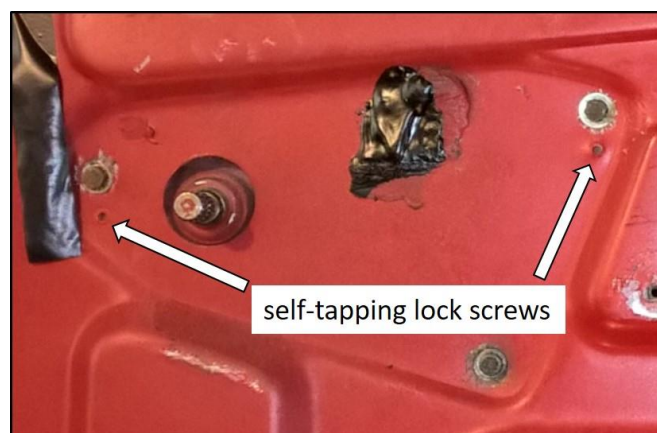
- (5) Remove the three machine screws that form a triangle around the window winder spindle. These release the regulator mechanism (item 1 in TAV77A) which comprises the winding mechanism and the arms which are responsible for the window lift. If the original regulator is still present, it may be additionally secured by two self-tapping screws, which were used to lock the final position of the regulator at the factory.

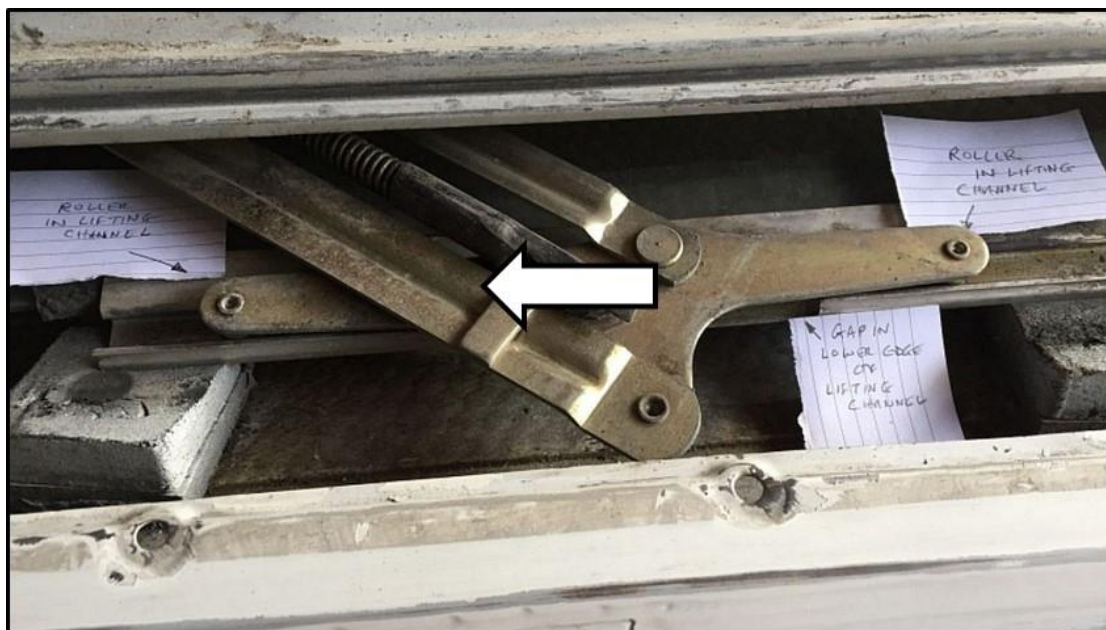
(8) Grasp the Regulator Mechanism (accessed through the large rectangular opening at the bottom of the door) and push it a couple of inches towards the (front) leading edge of the door. This will cause the two rollers of the lifting arms to detach from the Lifting Channel which is secured to the bottom edge of the glass. The lead roller will come out of the end of the Lifting Channel, and the other roller will drop through a gap at the bottom of the Lifting Channel.

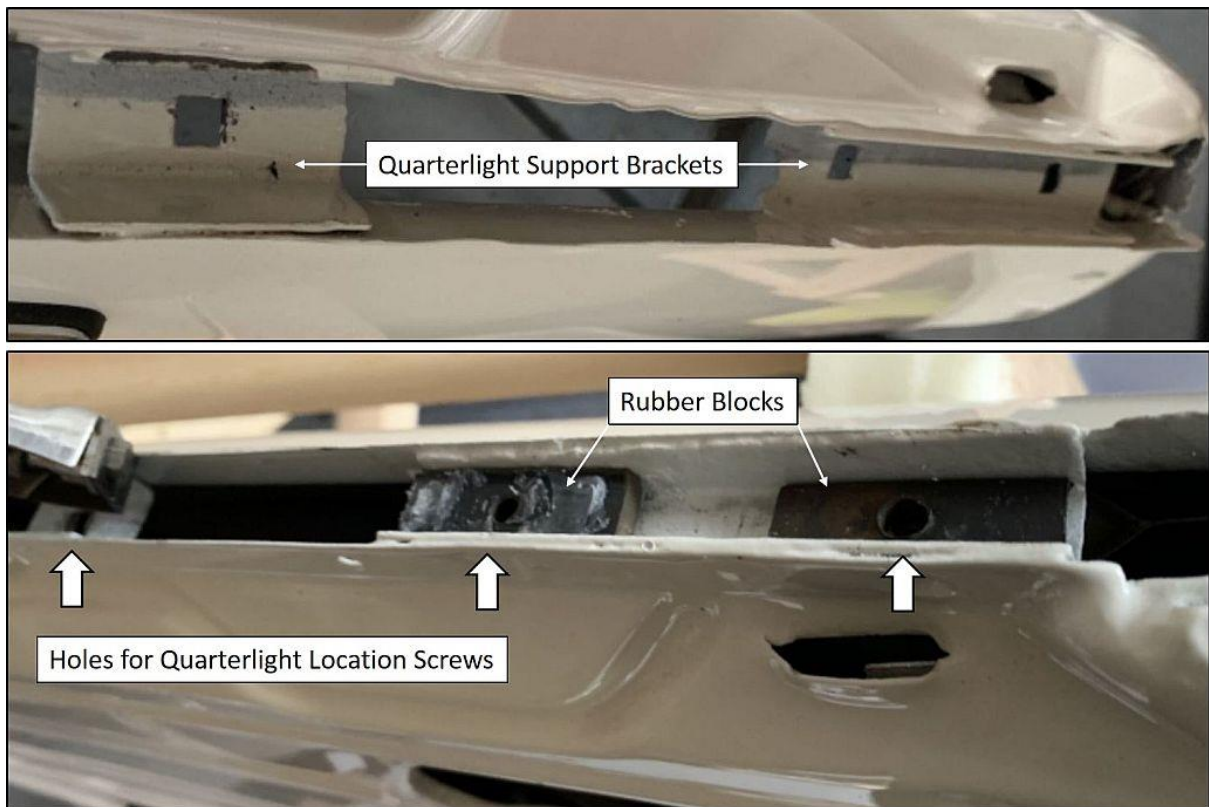
(10) Finally, the quarterlight assembly can be removed. In addition to the two screws that were removed in step 3, there are additional machine screws concealed under the quarterlight that attach its triangular frame to U-shaped brackets that span and brace the two door skins. The heads of the screws can be accessed through slots in the rubber seal when the quarterlight is fully open. There are three slots but, if you are fortunate, there may only be two screws present since one slot is close to the acute-angled corner of the frame and requires the use of a slim wrench when removing or replacing the screw, and is often missing. If original, these screws will be heavily corroded and may need to be removed by drilling/grinding their heads, or removing the caged nut which secures them below the brackets. Removing the heads will cause some damage to the window rubber, but this cannot be avoided. Rubber spacers should be found underneath the quarterlight when it is finally removed. These spacers came in various thicknesses and were used in the factory for fine adjustment of the height and angle of the quarterlight. They should be retained and their positions noted, for reinstallation later.

Some Fulvias were supplied with alloy doors, and in these cases, the support brackets may be riveted, rather than welded, to the door skins. When working on an alloy door, it can be easier to remove the rivets and then lift the brackets out with the quarterlight assembly. After removing these screws or freeing the brackets, the quarter light assembly can be pivoted back slightly towards the trailing edge of the door, swivelled inwards through 90 degrees to align the lower brackets with the door skins and then pulled upwards, withdrawing the quarterlight from the door. In all cases, when reassembling the doors, it is recommended to replace the quarterlight retaining screws with stainless or brass items, filing down the heads to fit the holes in the rubber seal if necessary, and protecting them with a heavy or copper-based grease to avoid future problems.

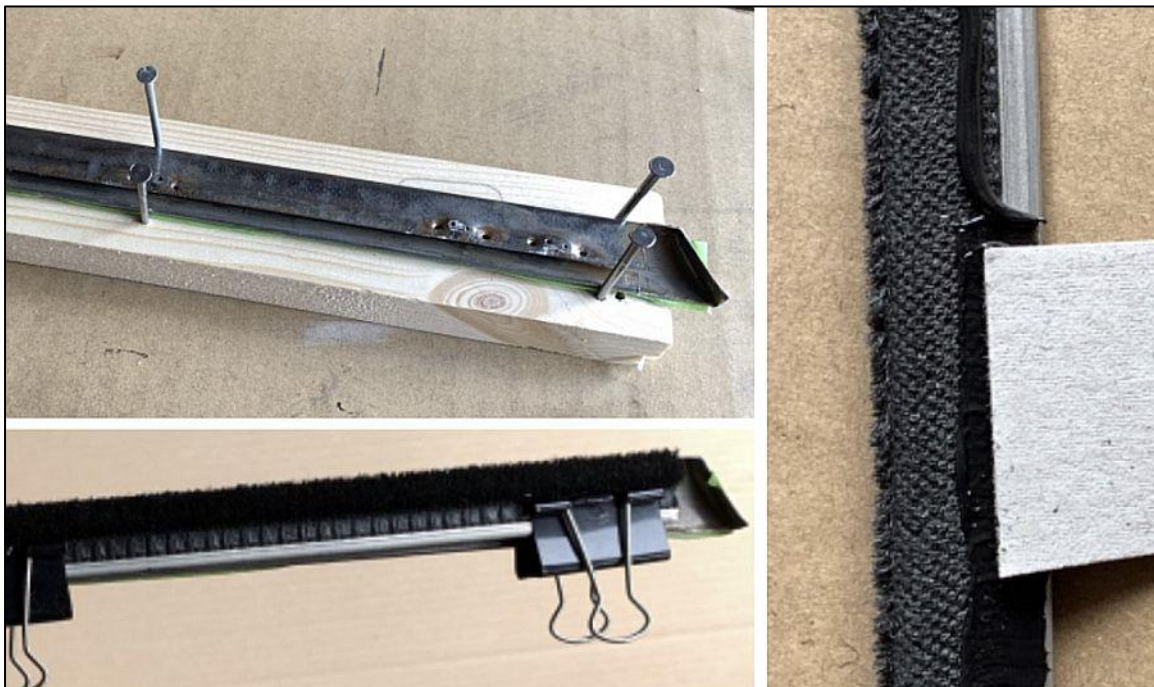
Since the exterior weather seal used staples, the holes required are smaller and more numerous. If following this procedure, it is advised to replace the iron staples with copper wire which can be secured by twisting and soldering. However, it may prove easier to use a flexible polyurethane adhesive instead to attach the weather-seal to the stainless steel strip. In both cases a small bead of flexible adhesive can be applied to the weather-strip, providing a waterproof seal.

To avoid 'adhesive creep', three small trim screws were added to the ends and middle of each weather strip. The protruding ends of these screws were then cut-off, to avoid scratches to the glass.

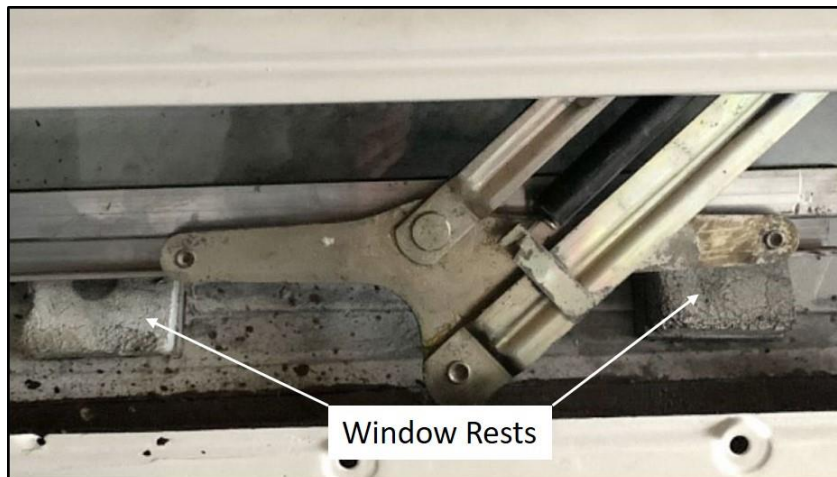
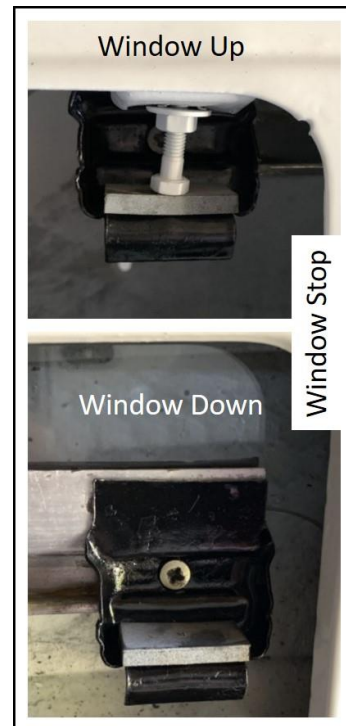
At the bottom of its travel, the window is supported by one or two foam rubber blocks which are glued to the inner face of the outer door skin (not shown in the Lancia Parts Manual). Their function is to stop the window rattling when driving with the windows open, so were an important feature in Italy. If no blocks are present, they should be replaced at this point.

Also not shown in the Parts Manual, but present in some cars, are sound deadening panels inside the door. These are usually glued to the lower sections of the outer door skin and were originally made of fibrous matting. Since these can retain water and accelerate corrosion, they should be removed and replaced with a modern closed-cell foam or polymer damping mat.
