Console and Dashboard (Instruments, Heater and Fusebox)

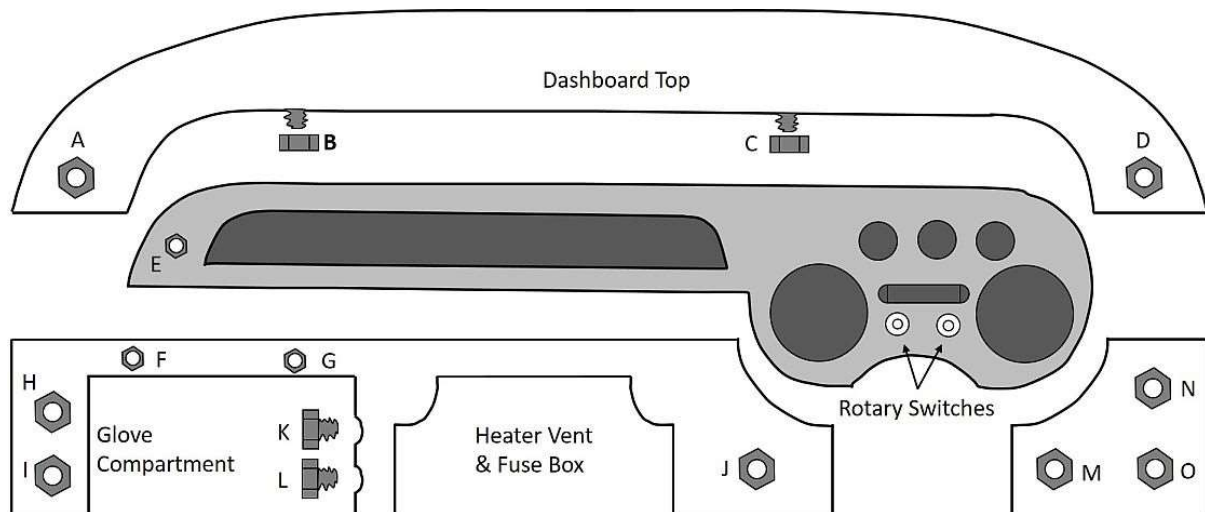
To gain access to the instruments, only the dashboard top must be removed. However visibility and access to retaining nut C is greatly improved if the lower panels are also removed or loosened.

The process starts with removing the lower plastic panel of the steering column (4 long screws) and the right-hand panel of the lower dashboard, which is held by three nuts (M-O) behind the panel. Nut M attaches the panel to a small bracket near the steering column. At this point, nut D can be removed.

Nuts A and B are accessible from the glove compartment, although this first requires removal of the radio, if fitted. The instrument panel can then be loosened by carefully removing nut E and the knurled rings which secure the rotary switches on the front of the panel. The bolt that attaches nut E is glued into the back of the wooden instrument panel and will be loosened if too much force is applied to nut E. If resistance is encountered, use penetrating oil to free nut E or first add a lock nut (or two locked nuts) to stop the bolt rotating.

If access to the heater and its control rods will be required, remove nuts F- J and the lower panel. You will also need to remove the grab handle (two machine screws and nuts) and the fusebox surround (not shown). To access the instruments only, remove nut J and pull this part of lower panel forwards. At this point nut C can be reached with a socket, square drive and a long 20-30cm extension.

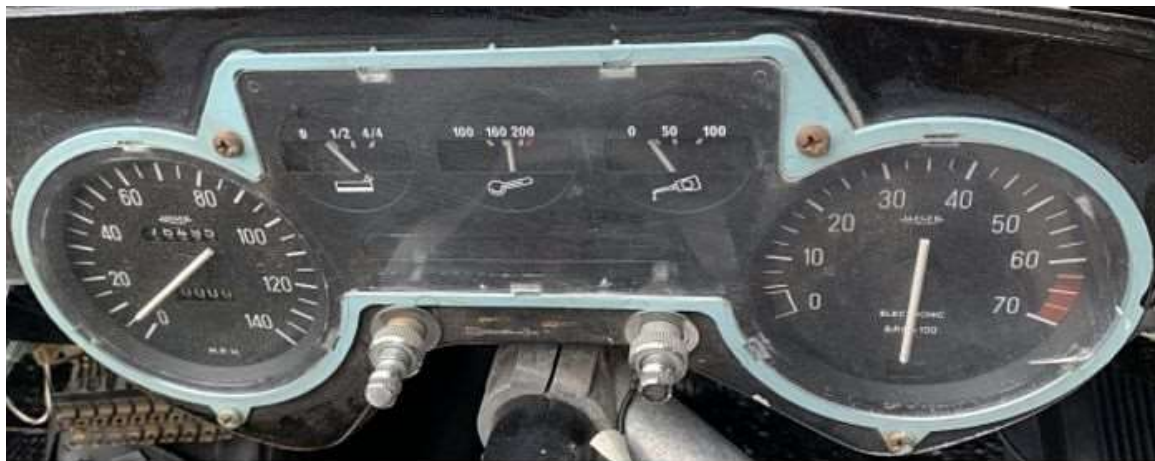
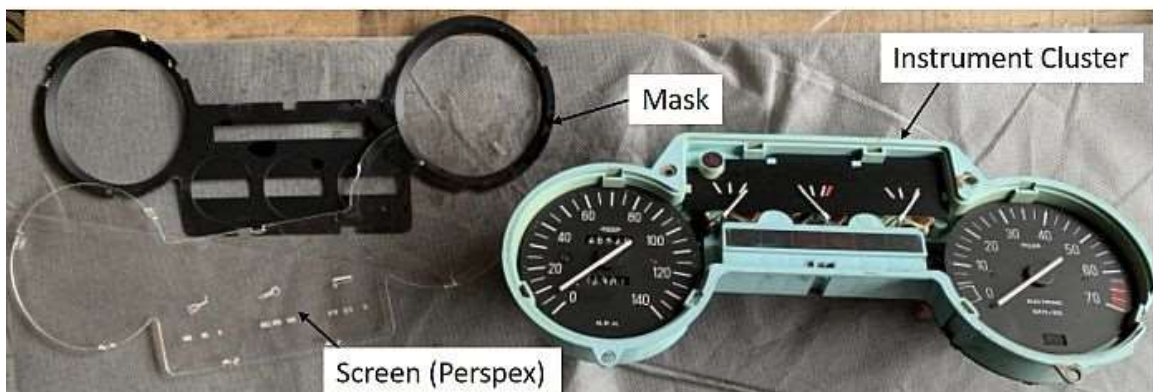
After removal of the dashboard top, unscrewing the knurled rings around the rotary switches allows the wooden fascia to be removed. The fascia sits in a groove formed by the lower panels and, if necessary, these should be loosened or removed first. With the fascia removed, access to the central instrument cluster (speedometer, rev counter, warning lights and gauges) is obtained. Removal of four securing screws, allows the cluster, contained in a light-blue plastic case, to be pulled forward to access the wiring behind. The cluster is attached to its wiring loom by two 8-pin connectors, one white and one red, which are numbered 37 and 42 on the S2 Fulvia Coupe wiring diagram (see Owners Notes 1, Appendix 1). Once these connectors have been separated, the instrument cluster can be extracted and dismantled on the bench.

The Perspex screen is removed from the cluster by using a small screwdriver to gently lift its tabs **from the rear**, after which the mask can be lifted off. These can be cleaned, polished and retouched as necessary.

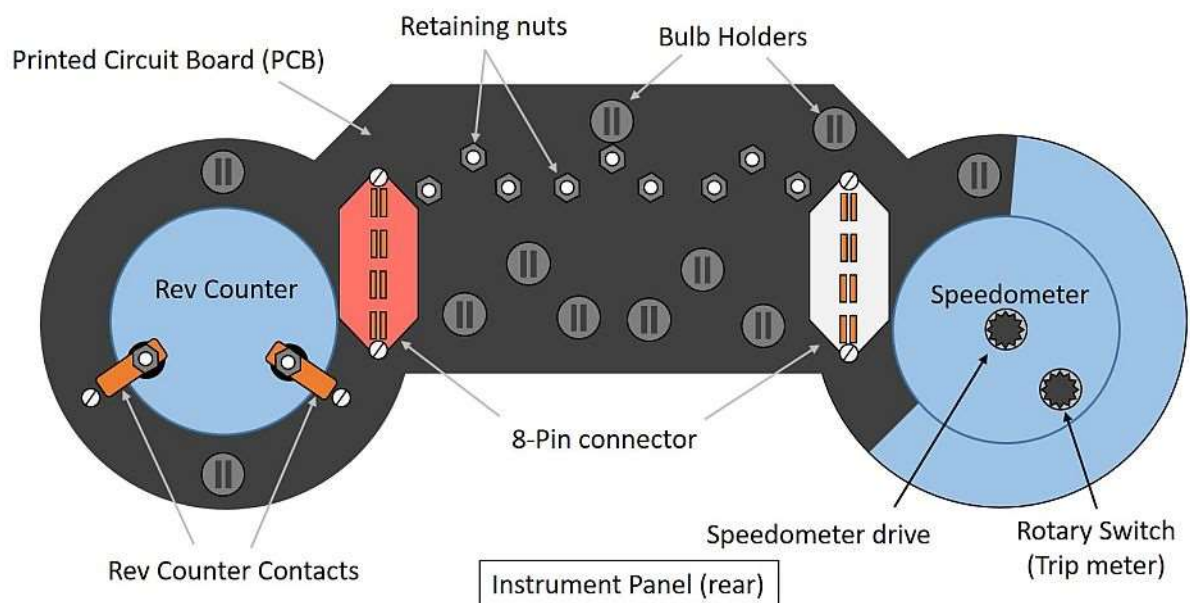
Electrical problems (intermittent failure of gauges, dim or faulty bulbs etc.) will require further dismantling. The blue instrument cluster is mounted on a black printed circuit board (PCB) which also provides the base for the 8-pin connectors.

Two nuts secure the rev counter to the PCB and another nine small retaining nuts attach it to a pod containing the three gauges (fuel, water and oil). These nuts also mark the points where the instruments make electrical contact with the hidden face of the PCB. Once all of the nuts and six self-tapping screws have been removed, the PCB can be lifted off and inspected.

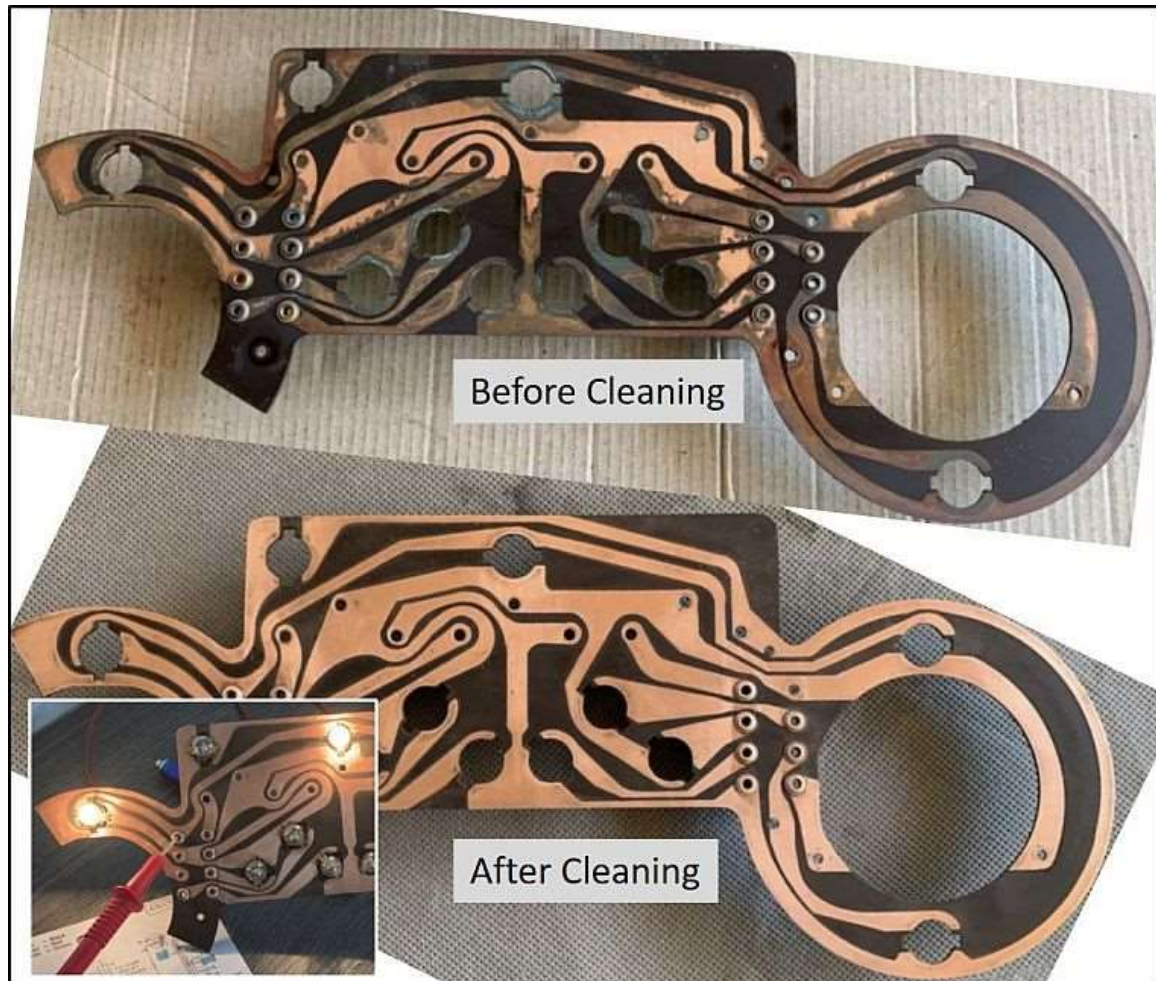
The PCB and its contacts to the instruments are subject to corrosion and so cleaning with fine emery paper or wire wool is advised. Dirty contacts can cause erratic movement and incorrect calibration

of the gauges and rev counter, as well as poor illumination of the instruments. Particular attention should be given to the areas where the bulbs and gauges make contact with the boards. These contacts are visible as small holes in the PCB in the photographs below.

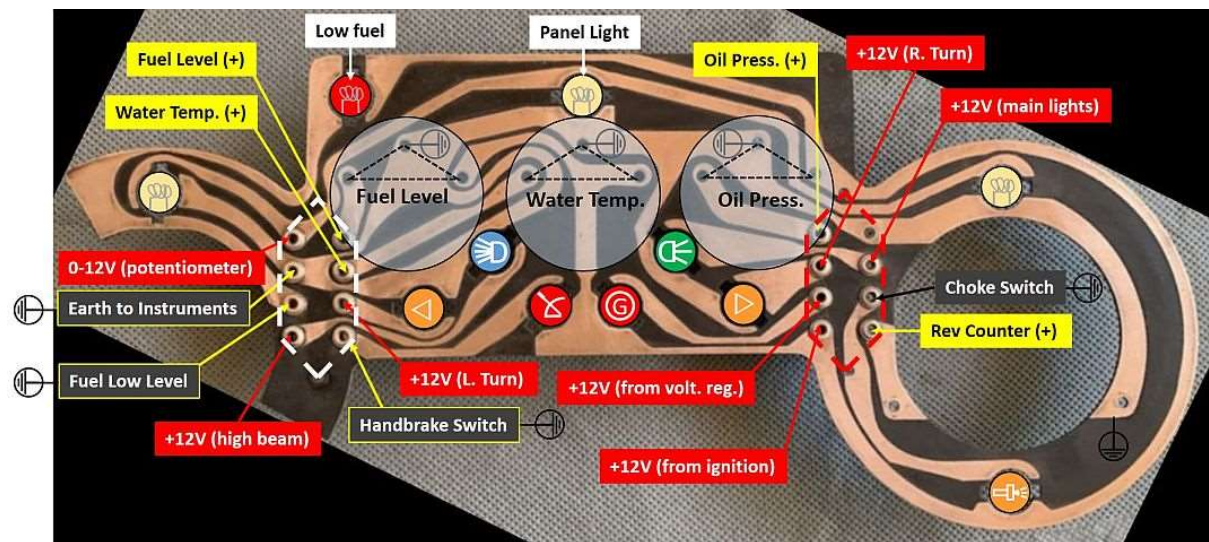
As a guide for later fault finding, the instrument panel PCB layout and its connections to bulbs, instruments and gauges are shown below and in Appendix XZ.

The bulbs that provide panel illumination use a common PCB circuit which is connected to a potentiometer, operated by one of the dashboard rotary switches. The 12V supply to the potentiometer is controlled by the main lighting switch (Fuse 1, sidelights). While the instrument panel is absent, this potentiometer should also be removed, tested and cleaned.

Bulbs that are used for the warning lights (fuel level warning, handbrake and choke) also share a common +12V ignition-controlled circuit but are earthed separately, through their switches, using individual circuits on the PCB.

Before re-installation into the instrument cluster, the circuits and the 8-pin connectors on the rear of the board should be tested for continuity and excessive resistance. It is also important to check the quality of the common earth that is provided to the board by a pin on the white 8-pin connector. This is supplied, via a terminal on the white 8-pin connector, from a lead that can be traced back from the connector, but which is usually attached to the body at nut J (lower dashboard panel fixing). This earth should be checked and cleaned before reassembly.
